## **INTERIM PROPERTY SURVEY**

### **STRATHAVEN: AVENDALE OLD AND DRUMCLOG**

### **PRESBYTERY OF HAMILTON - AREA 2**

**April 2019**

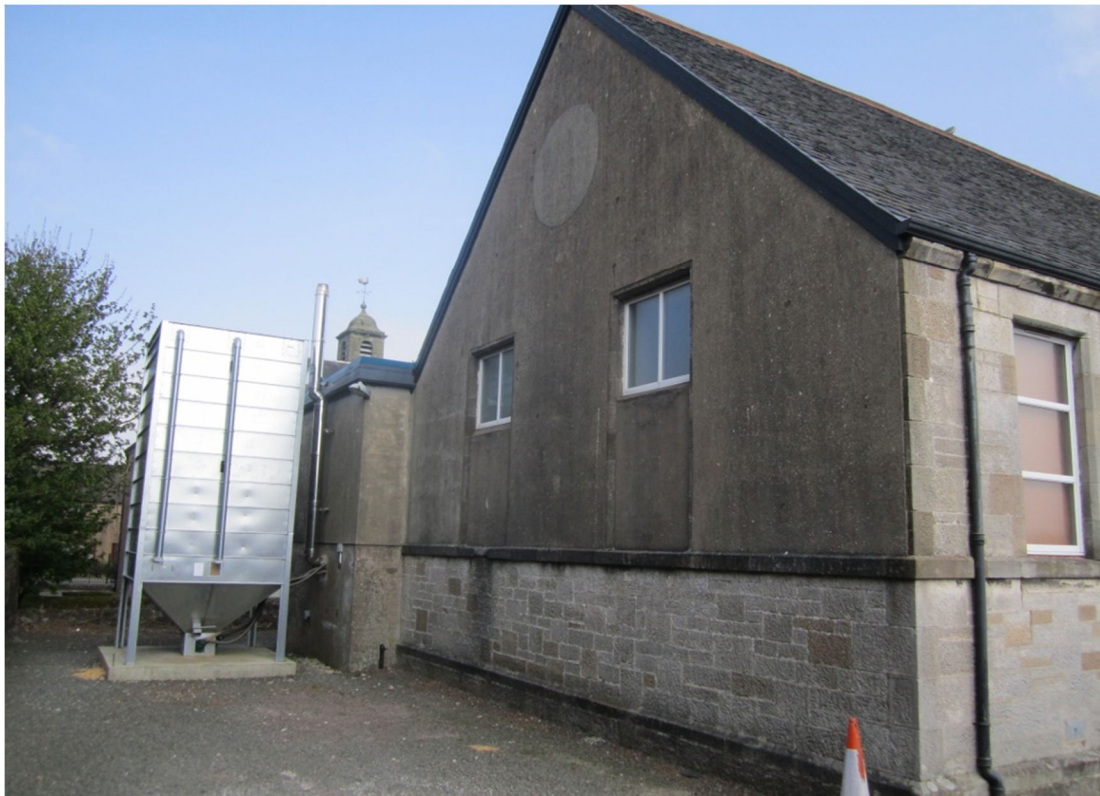
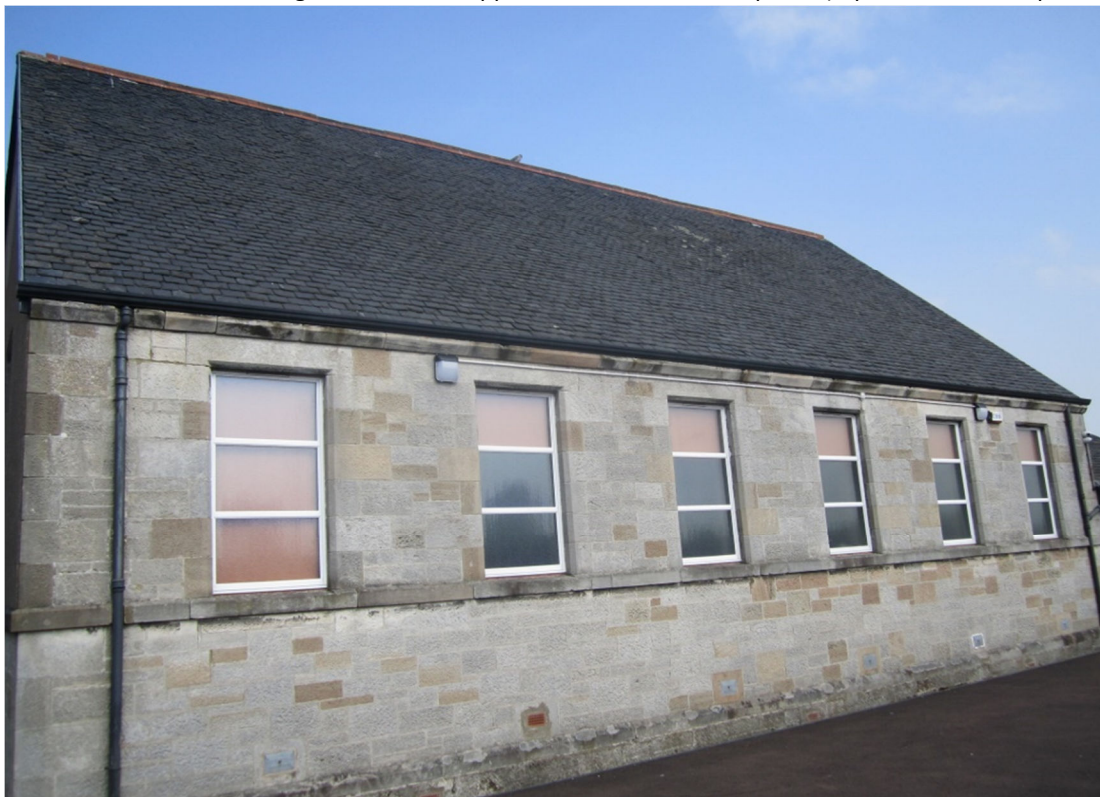
11 & 12 Slate roof over large hall will has slipped slates - overhaul required (replacement to be planned for)

Repairs have been carried out to the main slate areas and replacement lead flashings installed. However, it is likely that full replacement of the roof finishes may be required over the duration of this report – especially to the hall roofs.

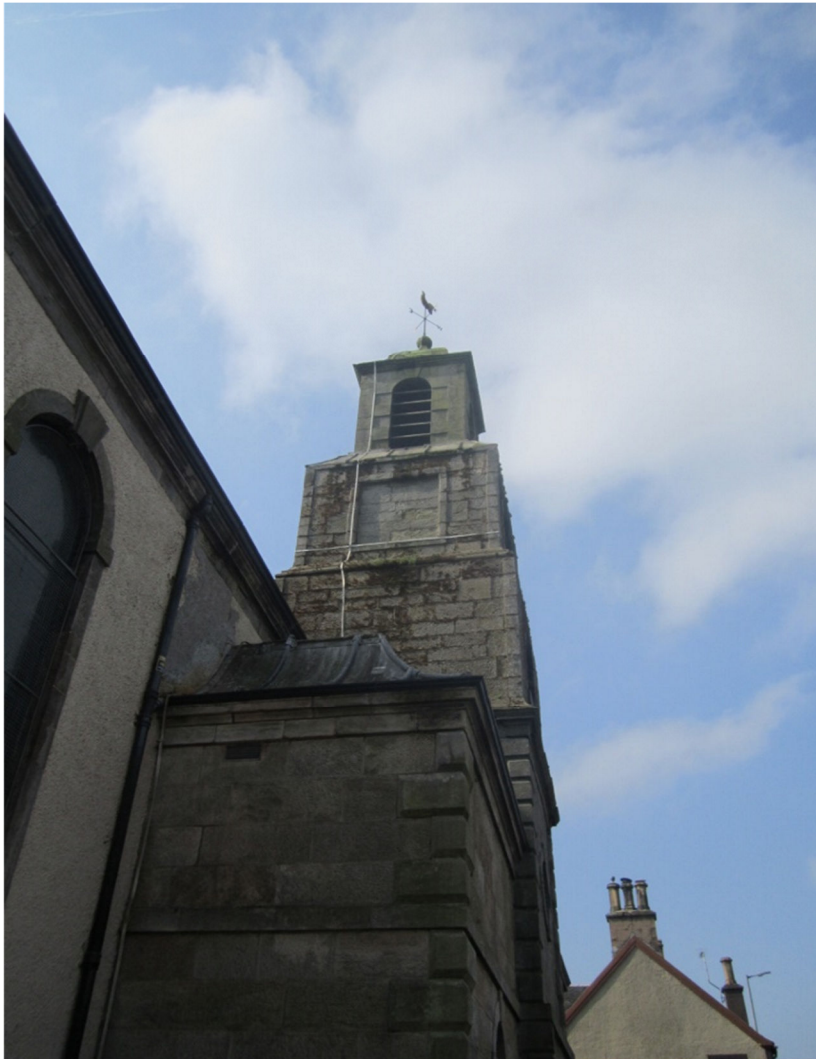
13 - Tower is mossy and has some vegetation to be removed

Repairs have been completed to stop the water ingress within the belltower - this has been dried out internally. Externally, there is moss and vegetation growth which indicates that the external face of the stonework is damp. The vegetation and moss should be removed at regular intervals and the stonework treated with an anti-fungicidal wash to limit further growth.

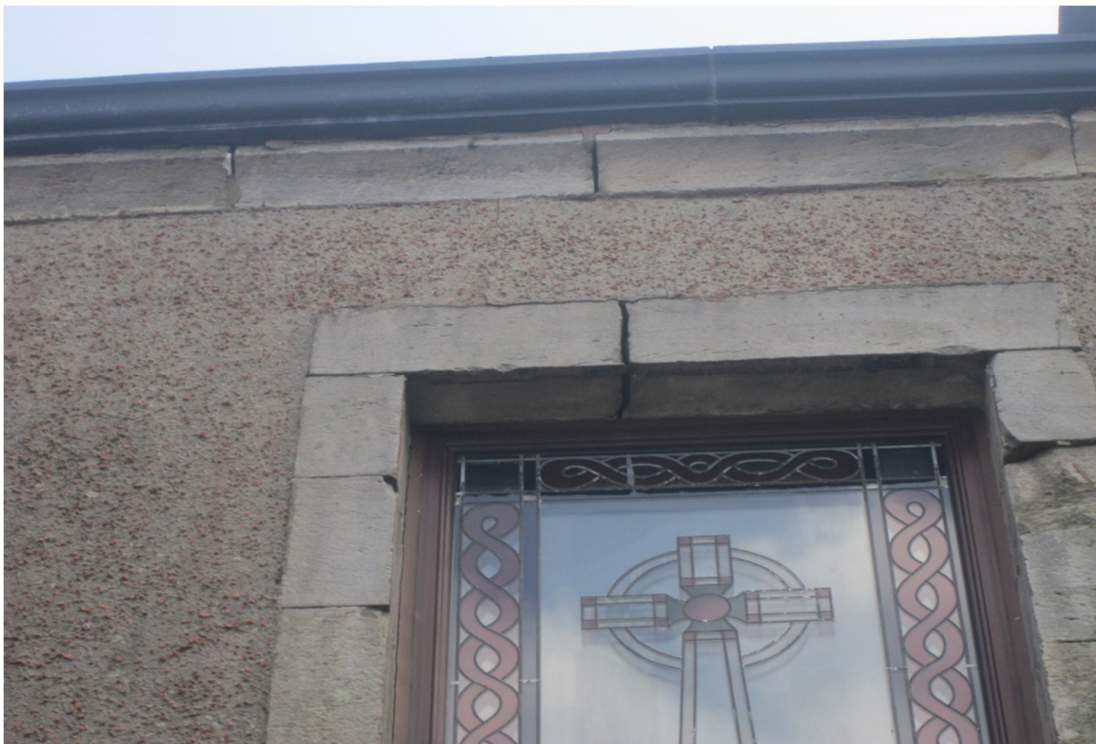
14 - Lintel above side window cracked

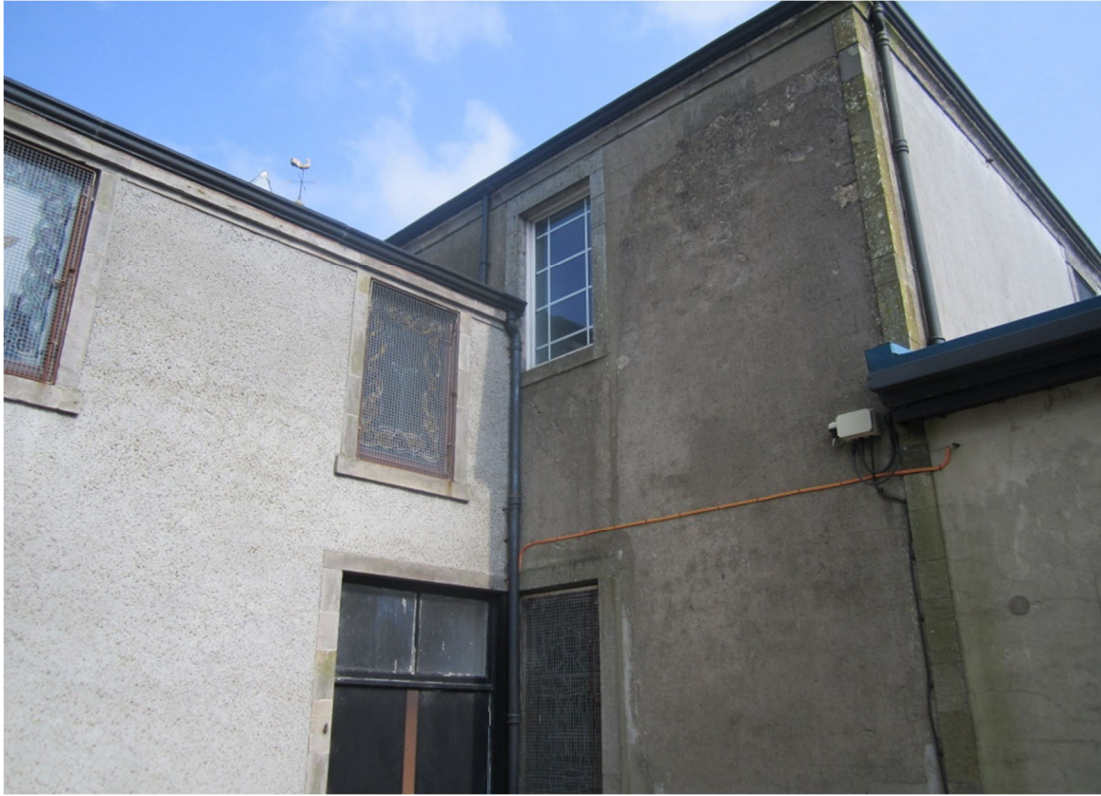
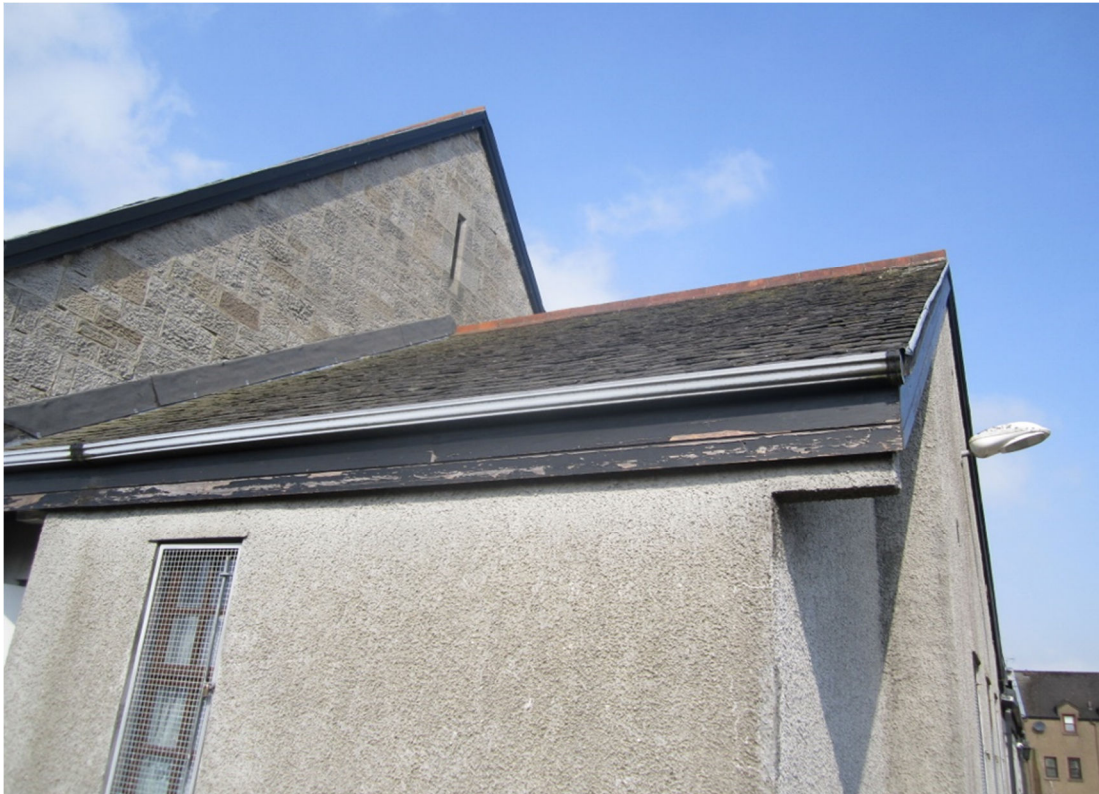
15 & 16 - External woodwork to be redecorated

Window frames around the toilet core still need to be repaired/replaced and all external woodwork requires redecoration with some areas of soffit and fascia to be replaced.

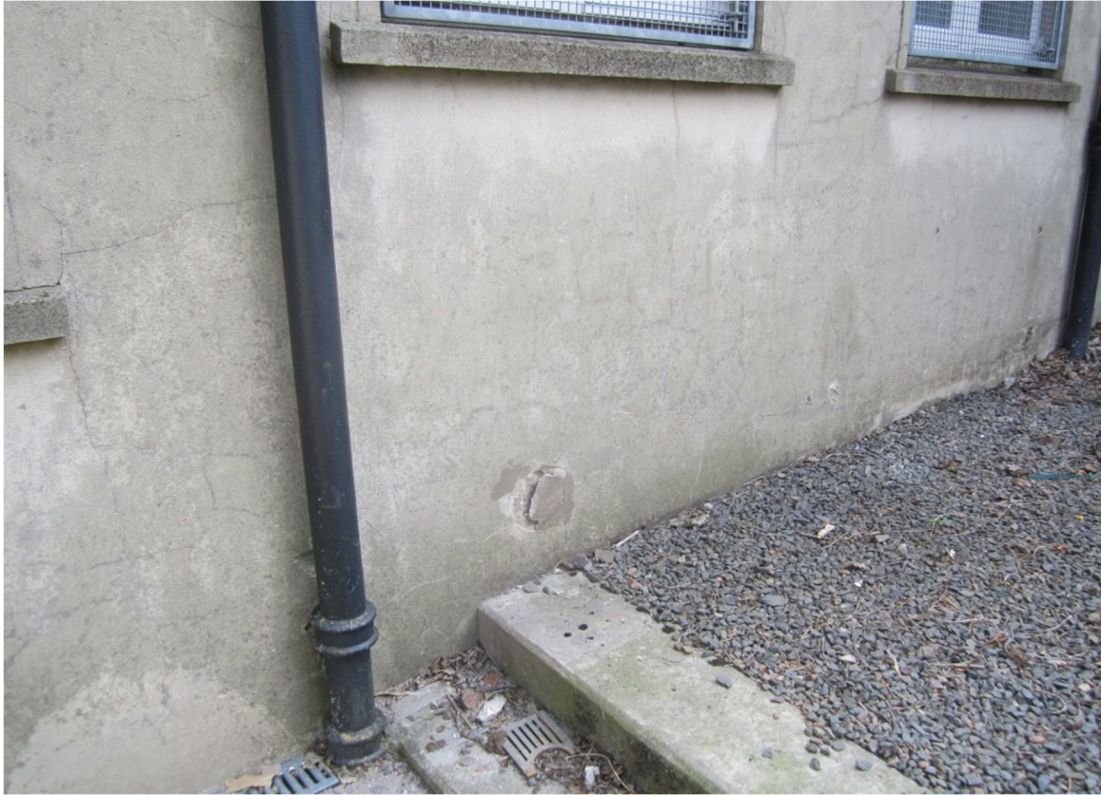
17 - Render damaged - no vents in wall

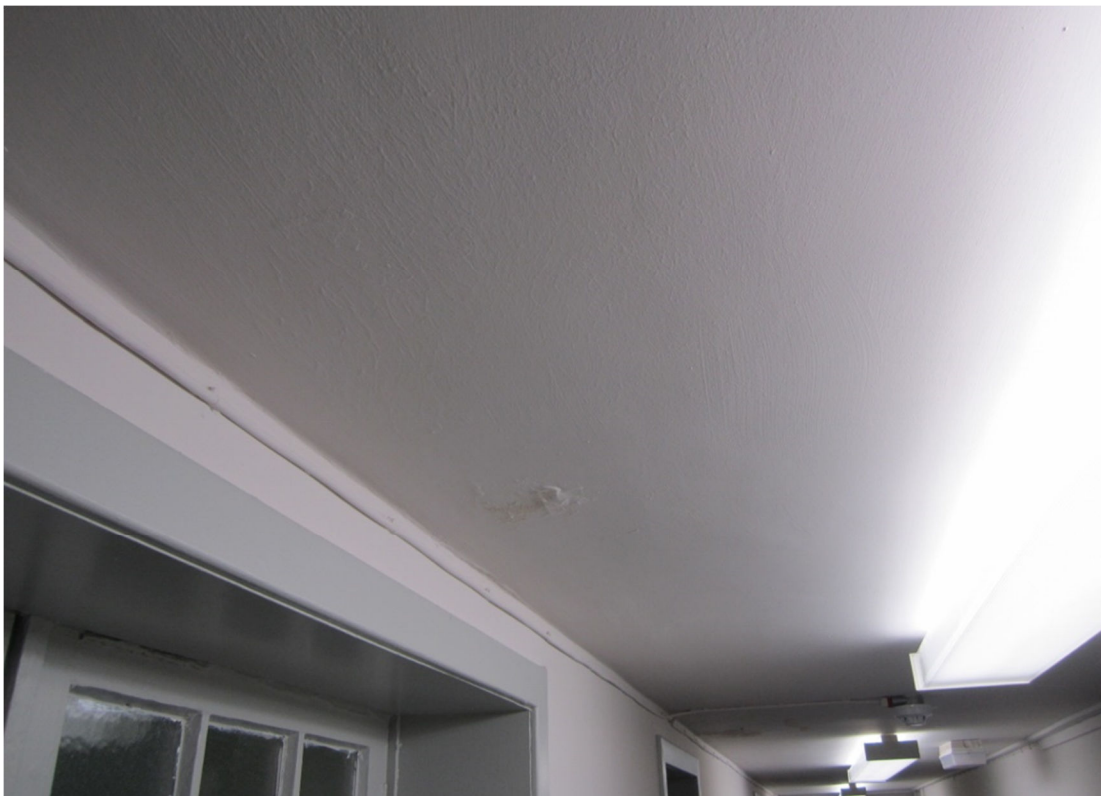
18 - Area of water damage in corridor ceiling

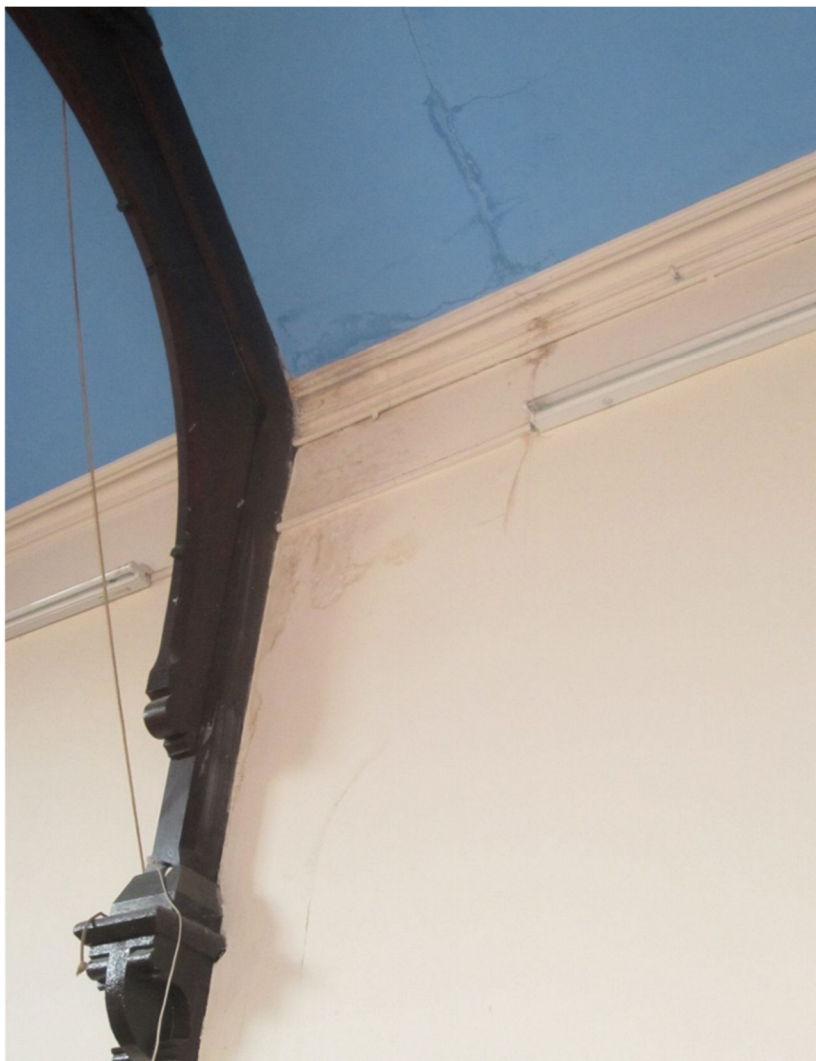
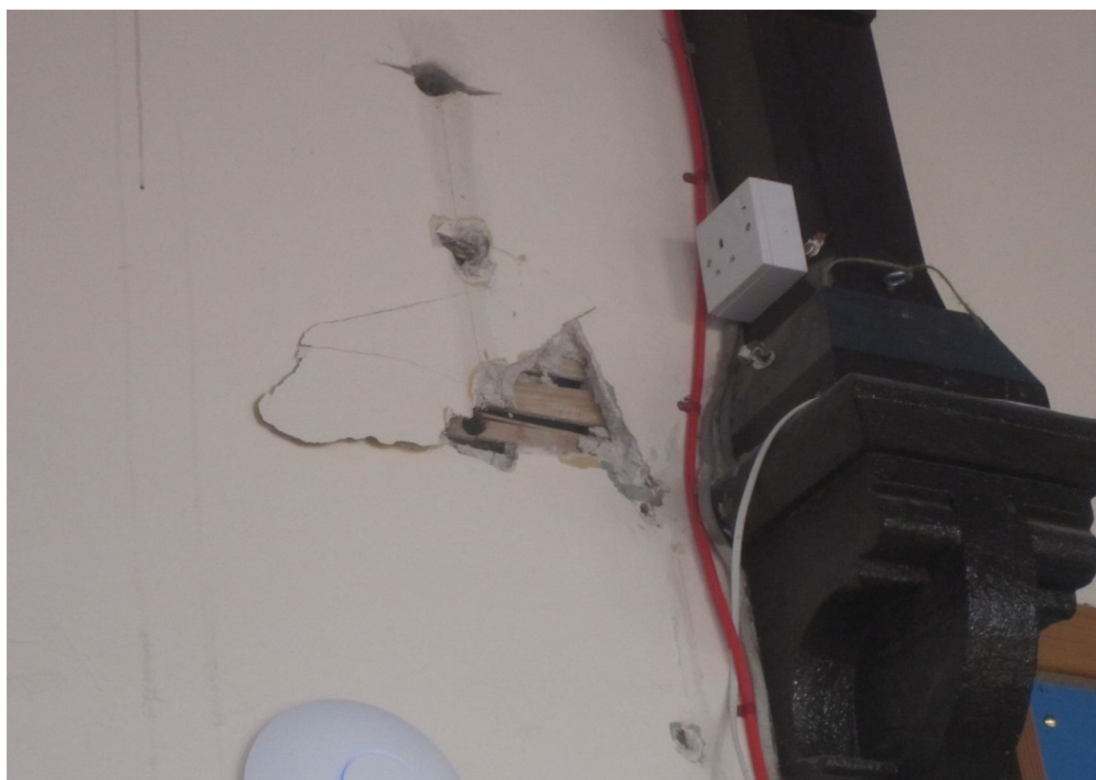
19 & 20 - Historic water ingress  
in large hall - plaster damaged  
from wifi installation

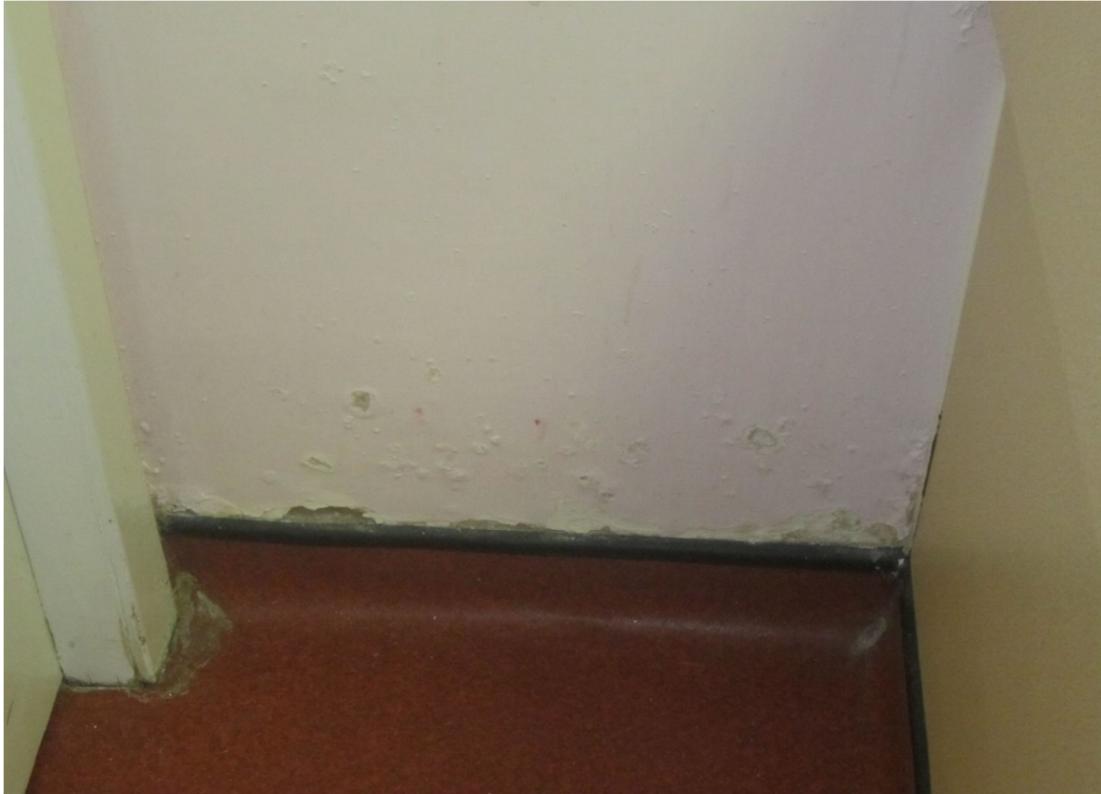
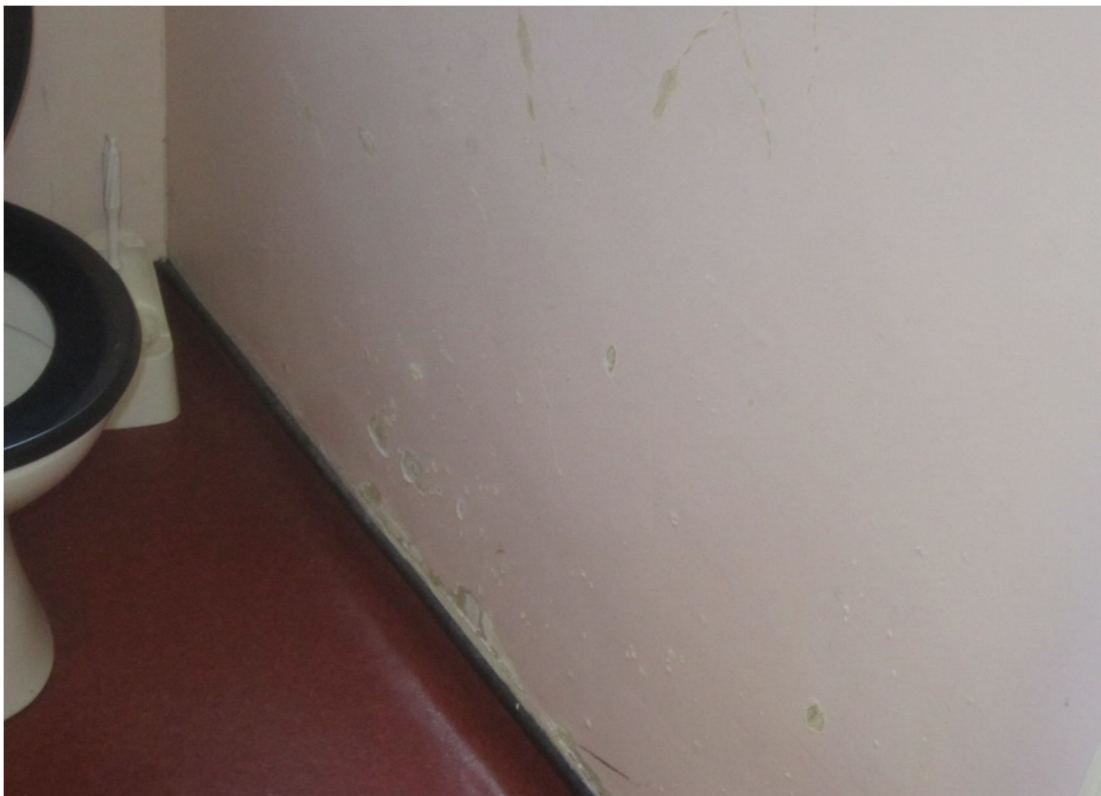
21 & 22 - Damp in female toilet

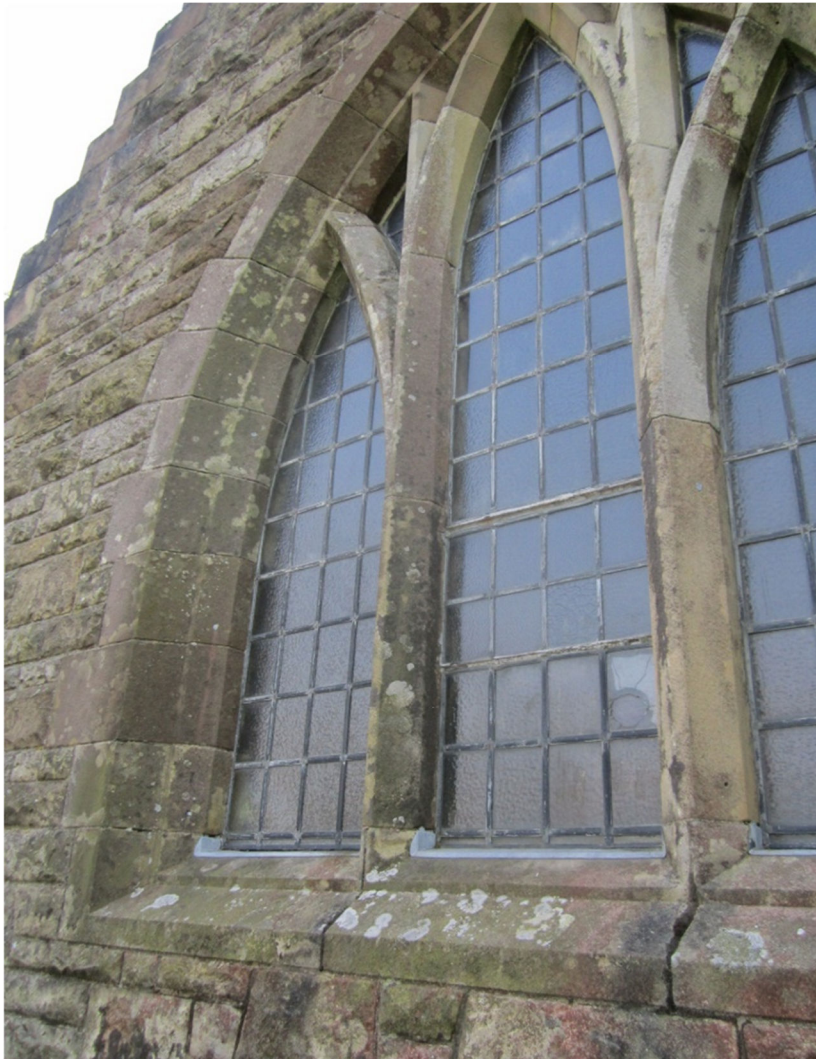
23 Open joints in ashlar stonework at window

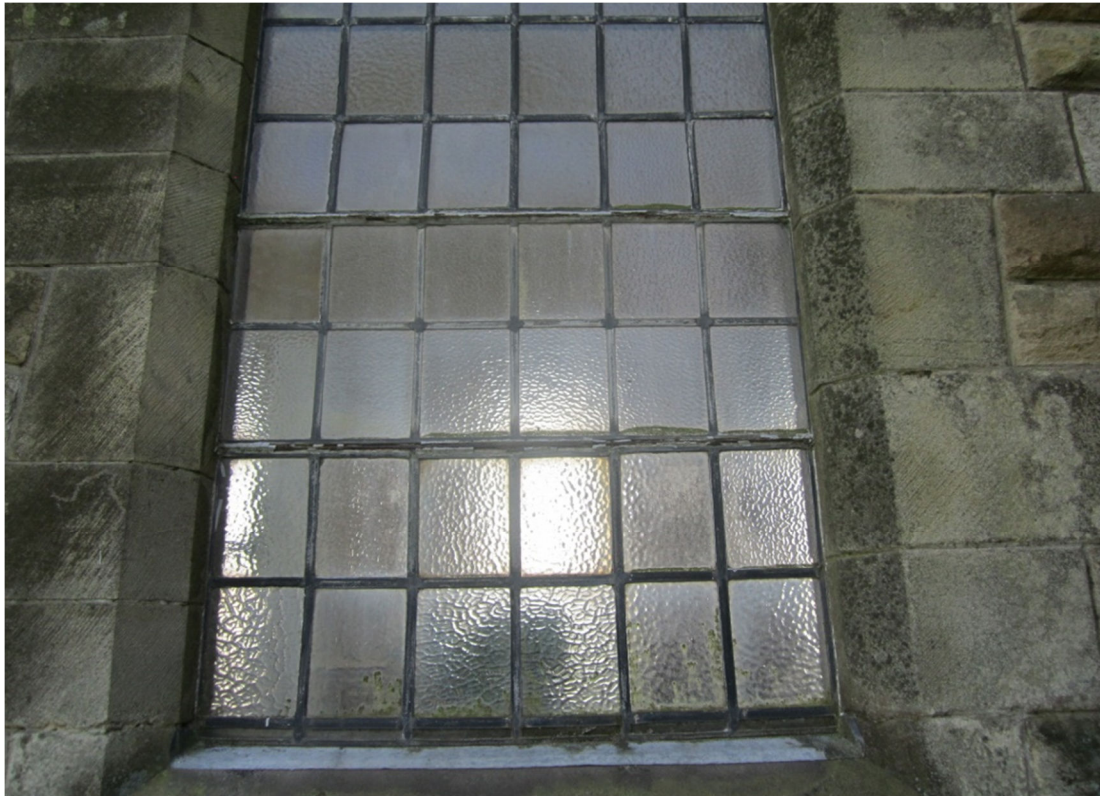
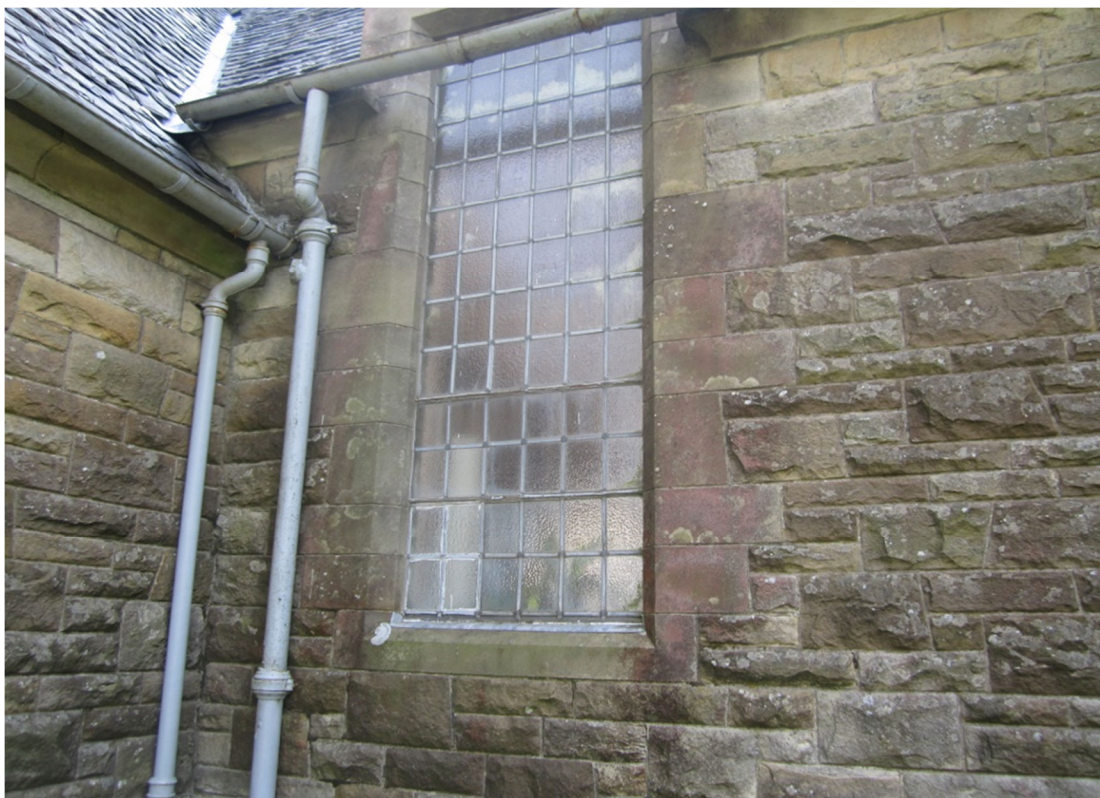
Some of the leaded windows are showing signs of slippage within their frames. A programme of restoration of these windows is required to avoid significant damage to the glass.

24 & 25 External view of slippage in leaded windows

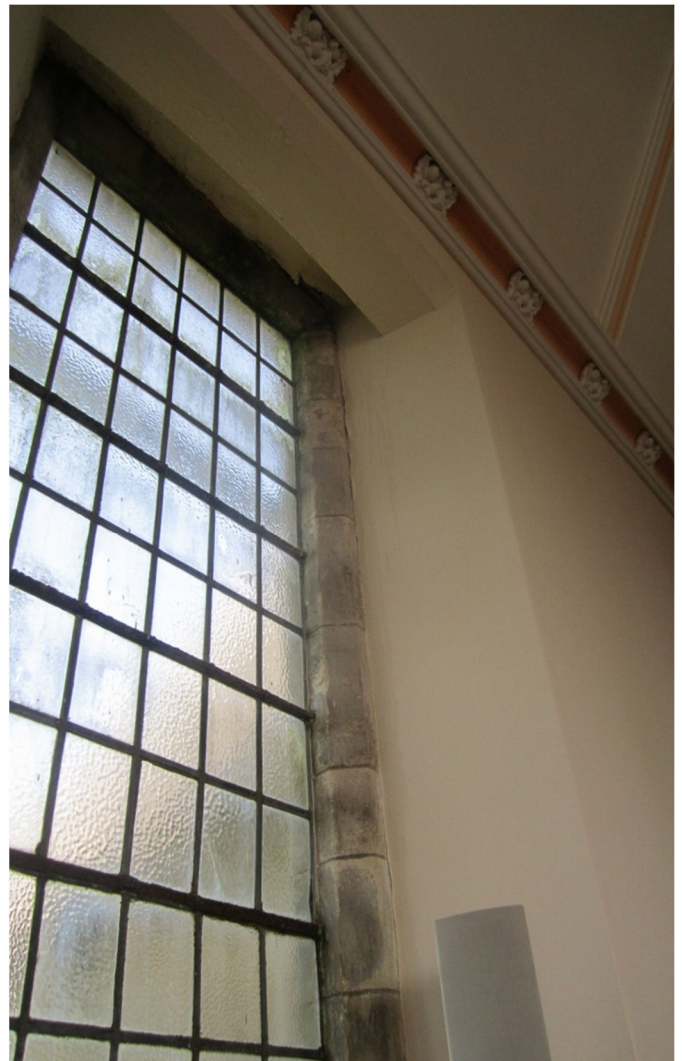
26 & 27 Internal view of slippage in leaded windows

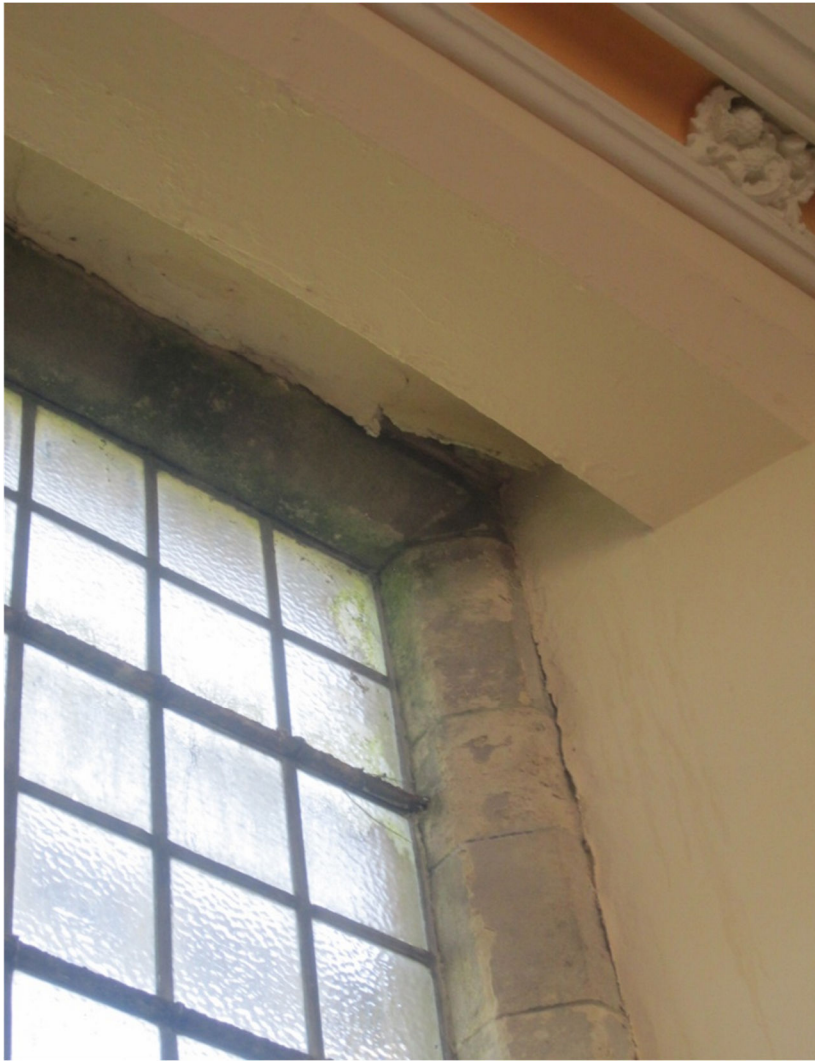
There is historic water damage on areas of the sanctuary walls and redecoration of these areas is required.

28 - Historic water ingress above windows in sanctuary

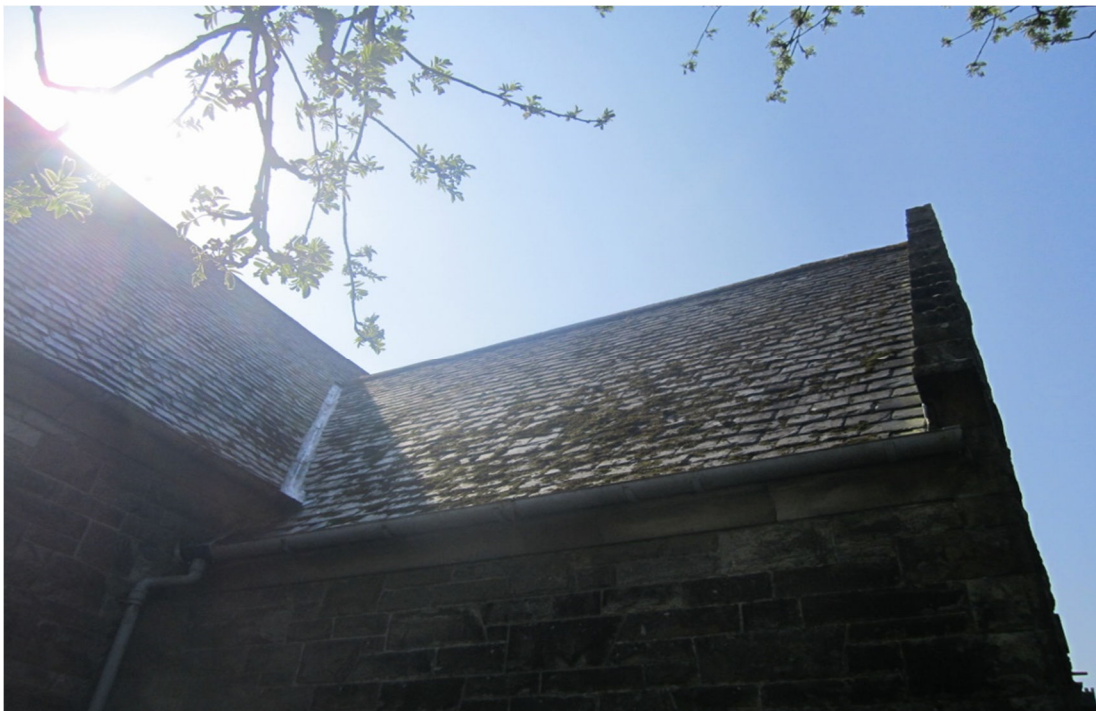
29 Moss to be removed from slate roof

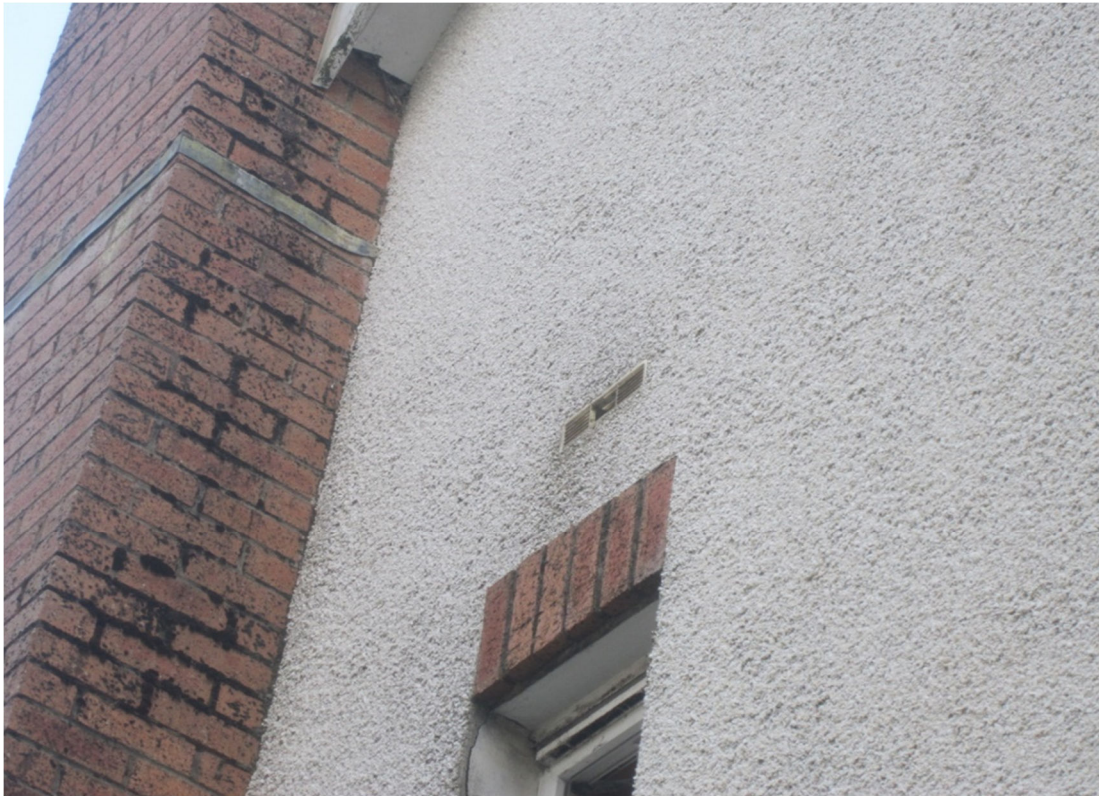
30 New grille required to vent above ensuite windows

Some of the window sills have open joints requiring repointing and the cement render to the window ingoes is cracking in places – this should be removed and replaced to avoid water ingress. The extract grille above the ensuite window is broken and should be replaced.

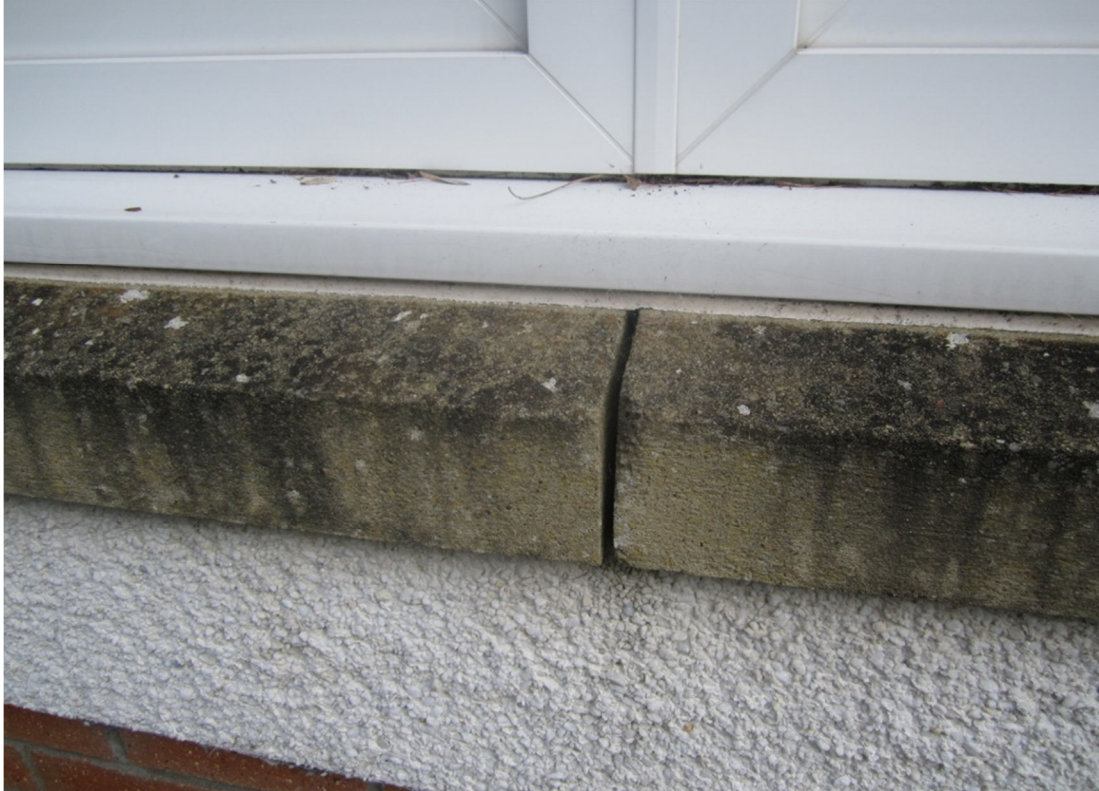
31 Open joints in reconstituted stone window sills

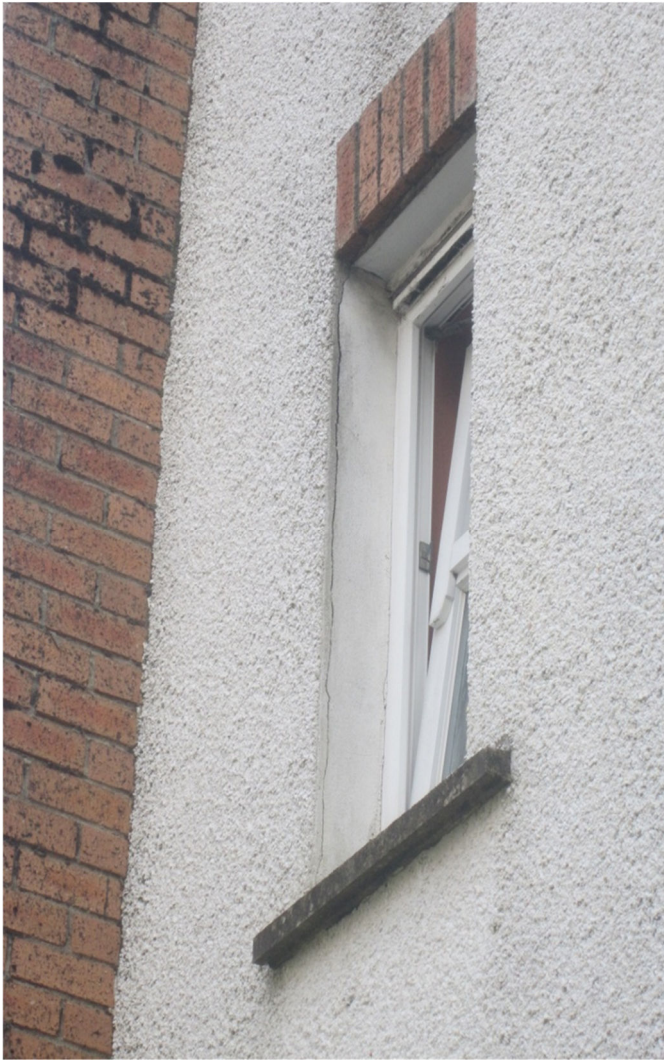
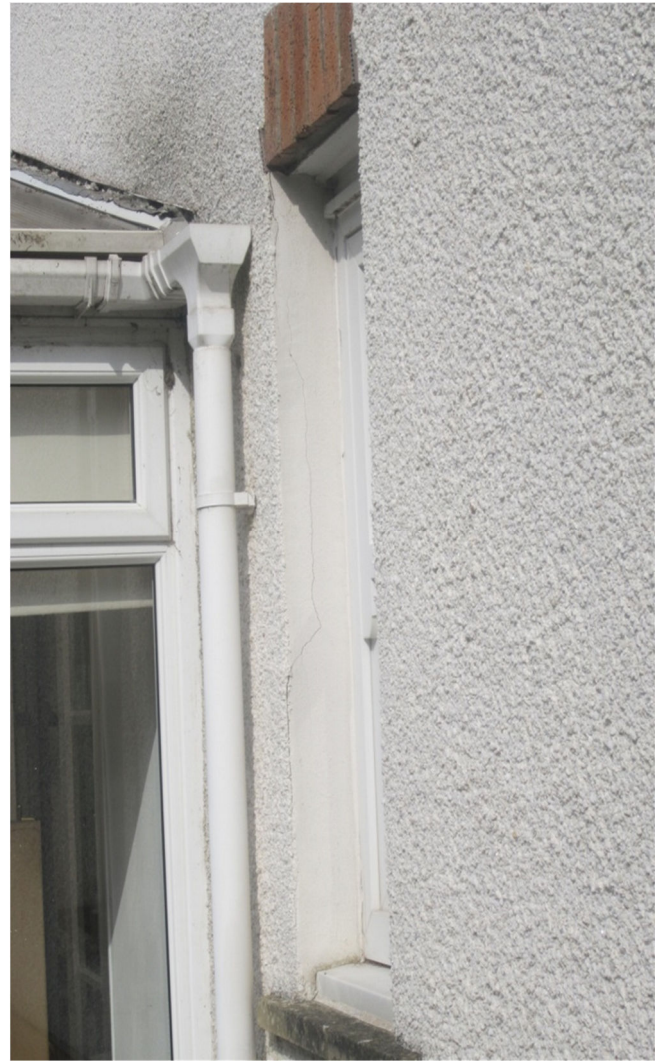
32 & 33 Render cracked at window ingoes

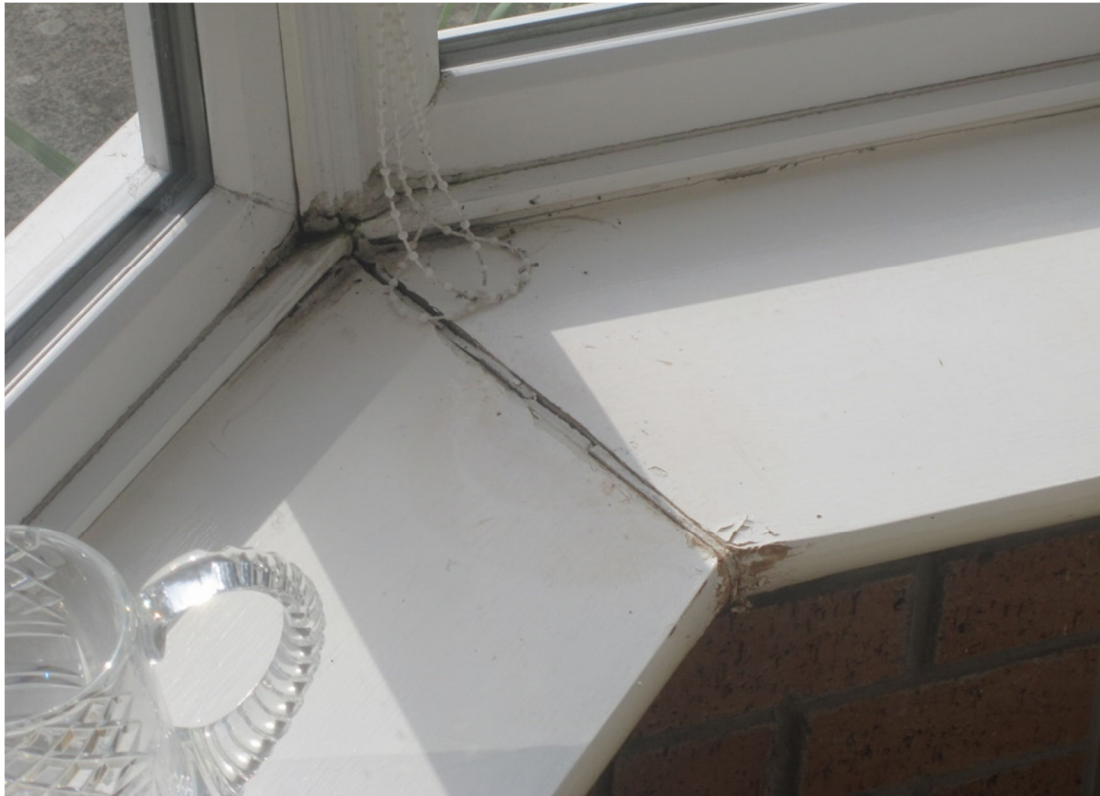
The window sills in the conservatory are opening up due to expansion and contraction caused by the temperature changes in the conservatory. These joints should be resealed.

34 & 35 Open joints in window sills in conservatory
