## **INTERIM PROPERTY SURVEY**

### **STRATHAVEN: AVENDALE OLD AND DRUMCLOG**

### **PRESBYTERY OF HAMILTON - AREA 2**

**April 2019**

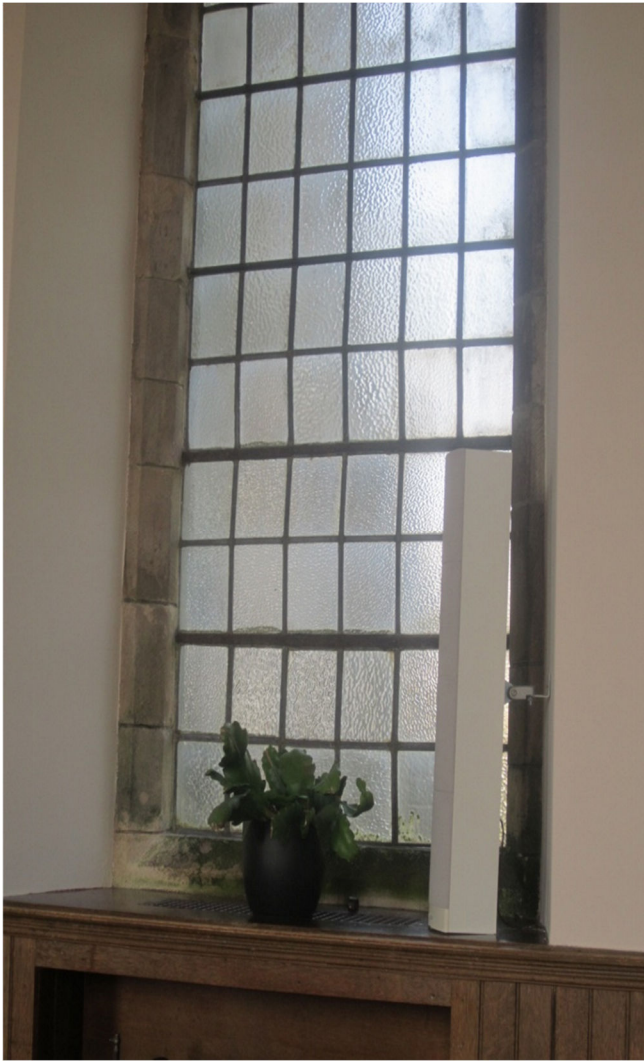
Some of the leaded windows are showing signs of slippage within their frames. A programme of restoration of these windows is required to avoid significant damage to the glass.

26 & 27 Internal view of slippage in leaded windows

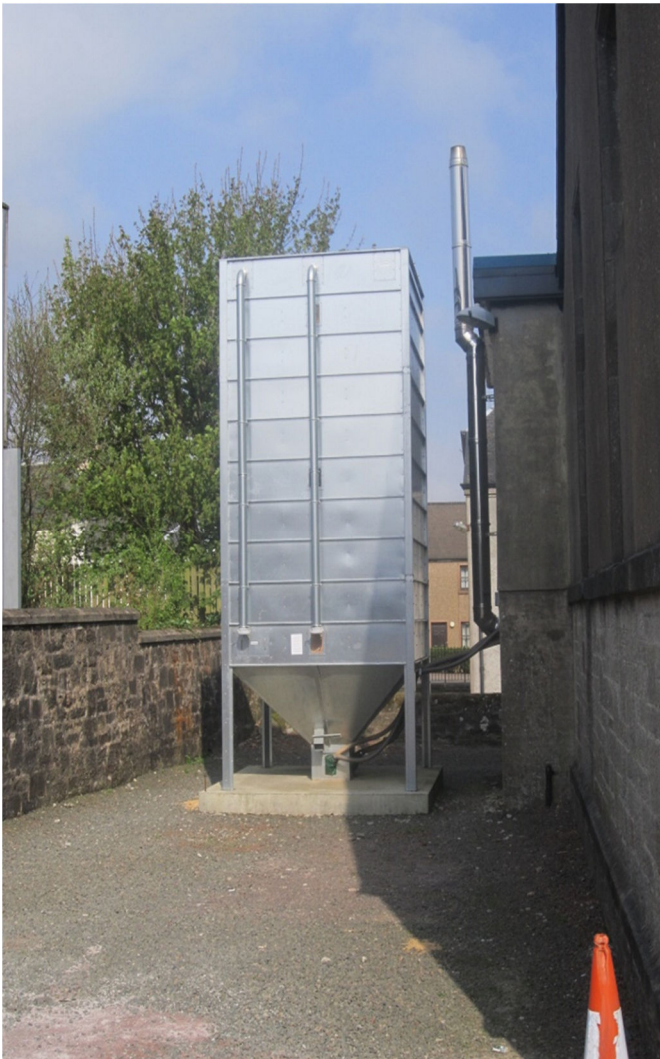
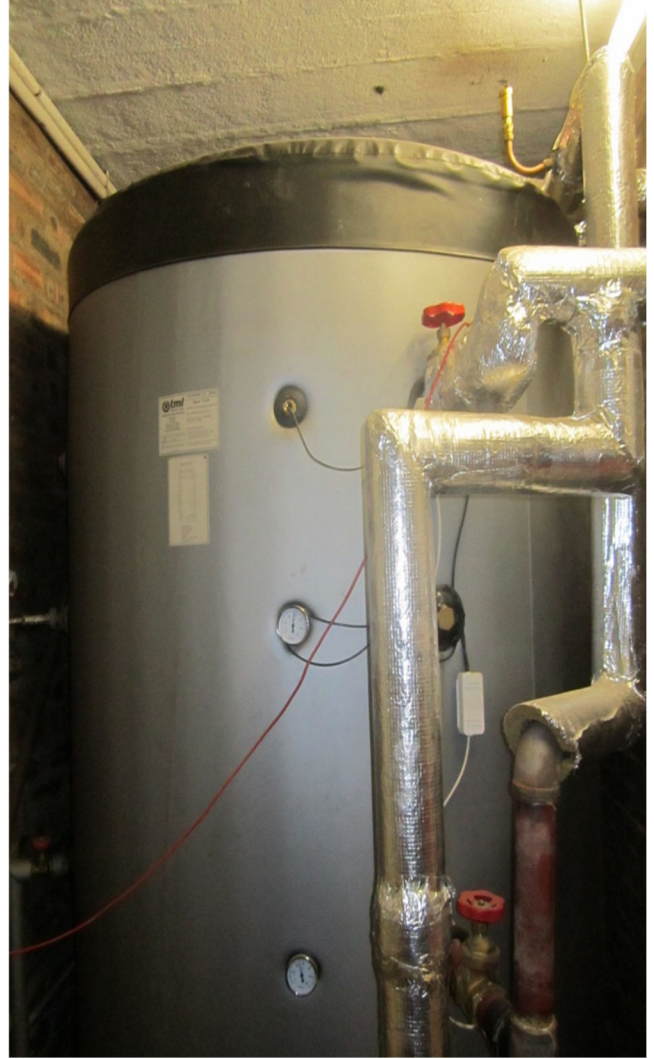
36 & 37 Biomass boiler and storage

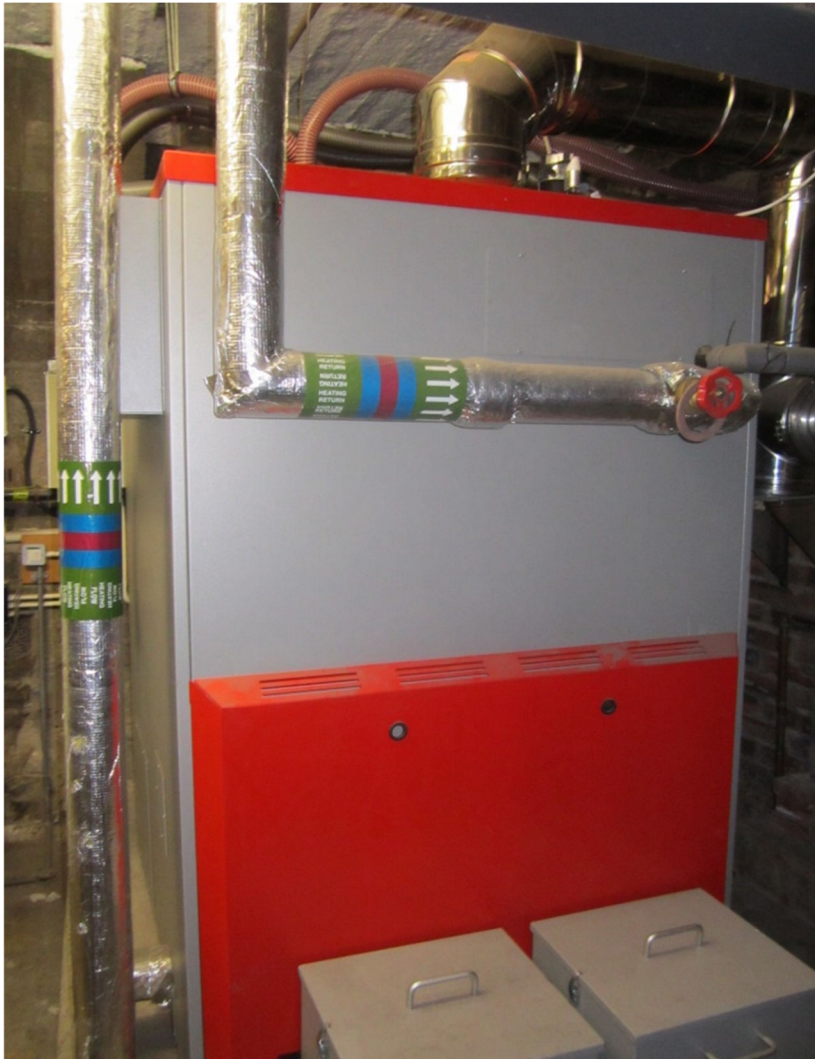
38 - Original boilers retained as back-up

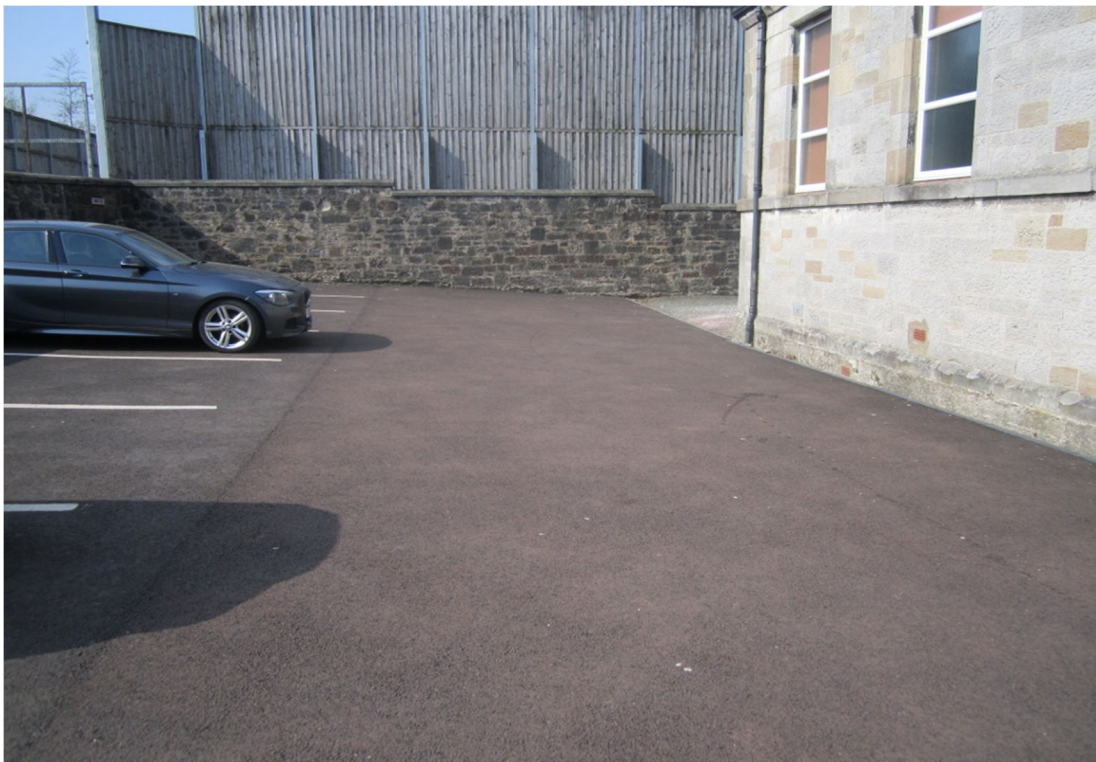
The car park has been resurfaced and lined and the stone boundary wall repaired. A drainage channel has been installed to the full perimeter of the church and halls to assist in shedding water from the hard landscaped areas.

39 Car park resurfaced and lined

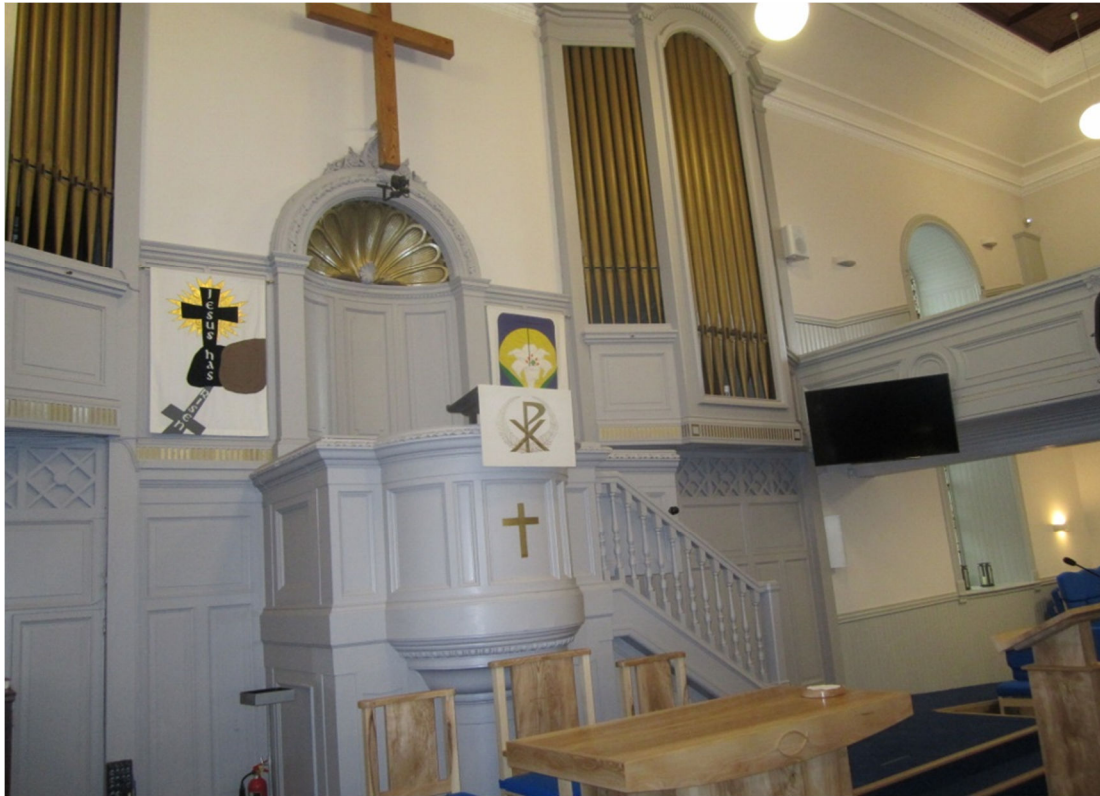
The sanctuary and vestibule areas have had major alteration and refurbishment works carried out since the last report. These works have been completed to a high standard to create an accessible, flexible space. These works have required dedication and commitment from the congregation. The stained glass windows require some restoration and a programme of repairs is required over the next few years as funds become available.

40 & 41 Sanctuary refurbished since last report

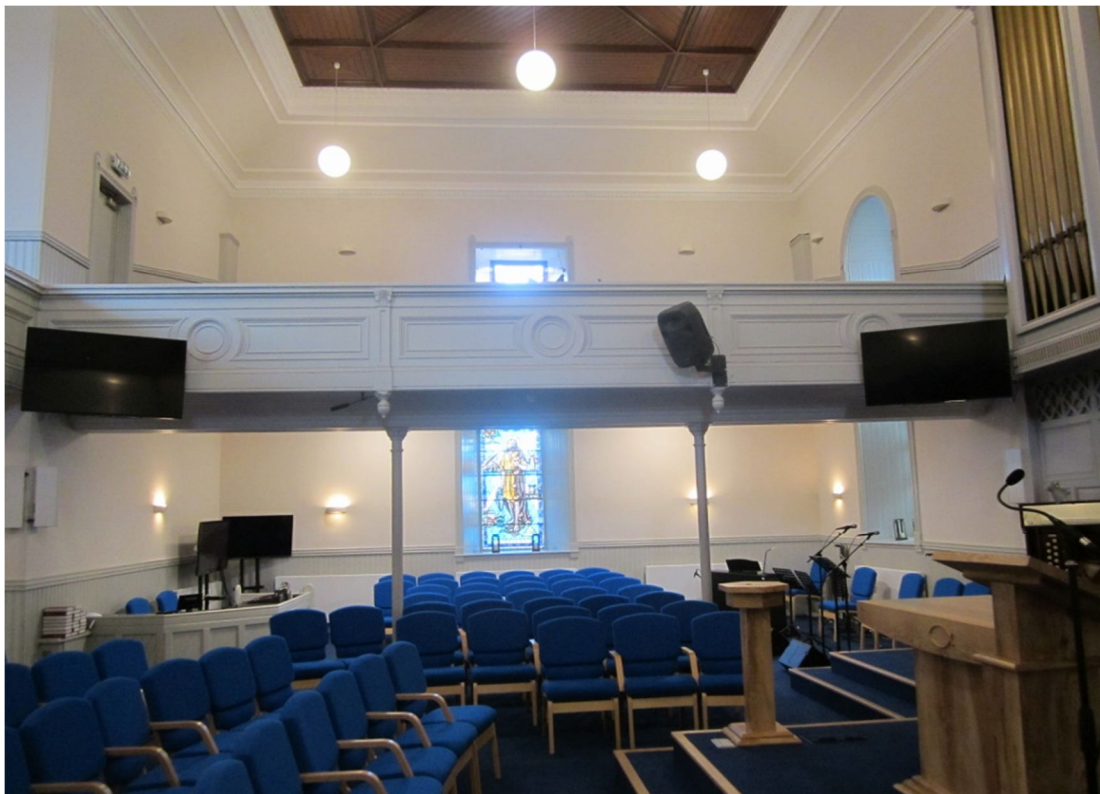
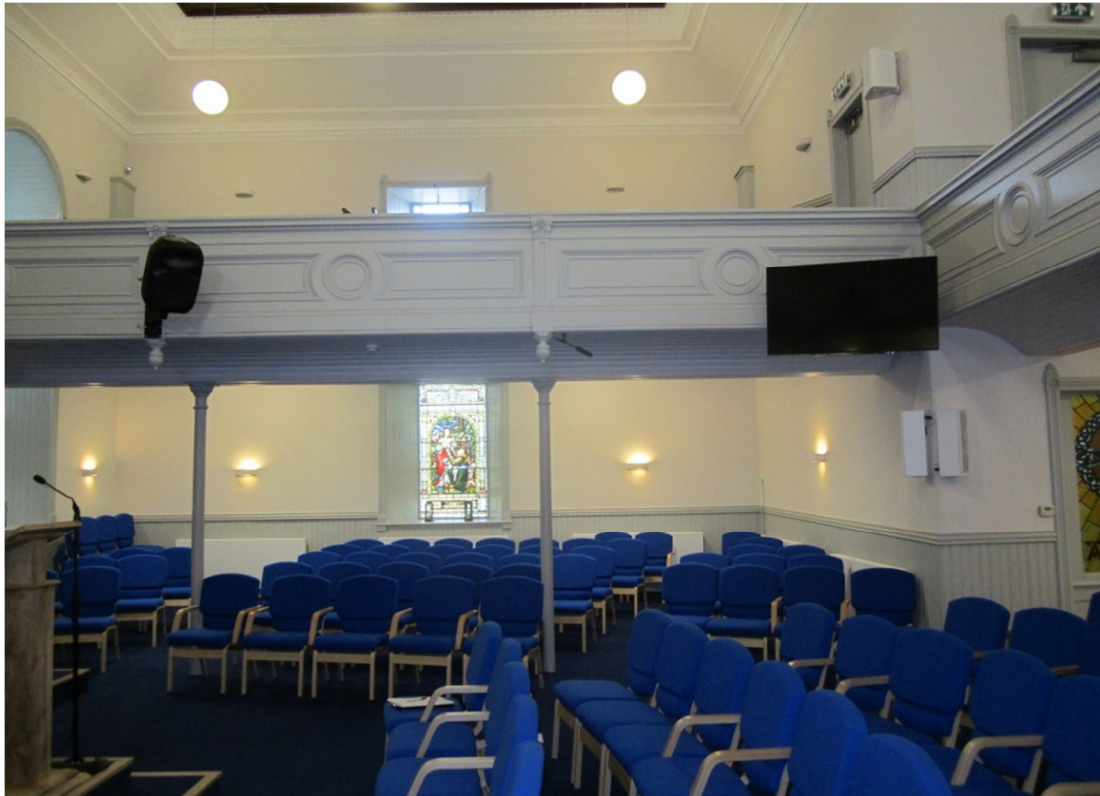
42 & 43 - Sanctuary refurbished

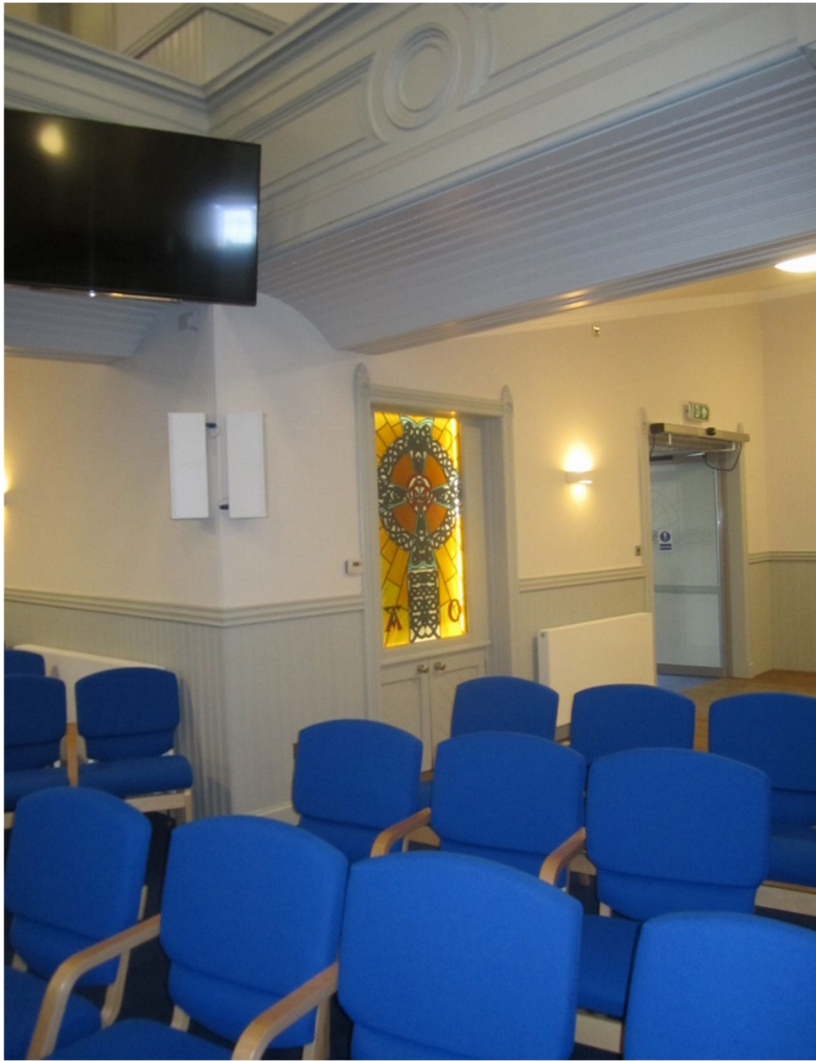
44 Door infilled and new opening with electrically operated door formed

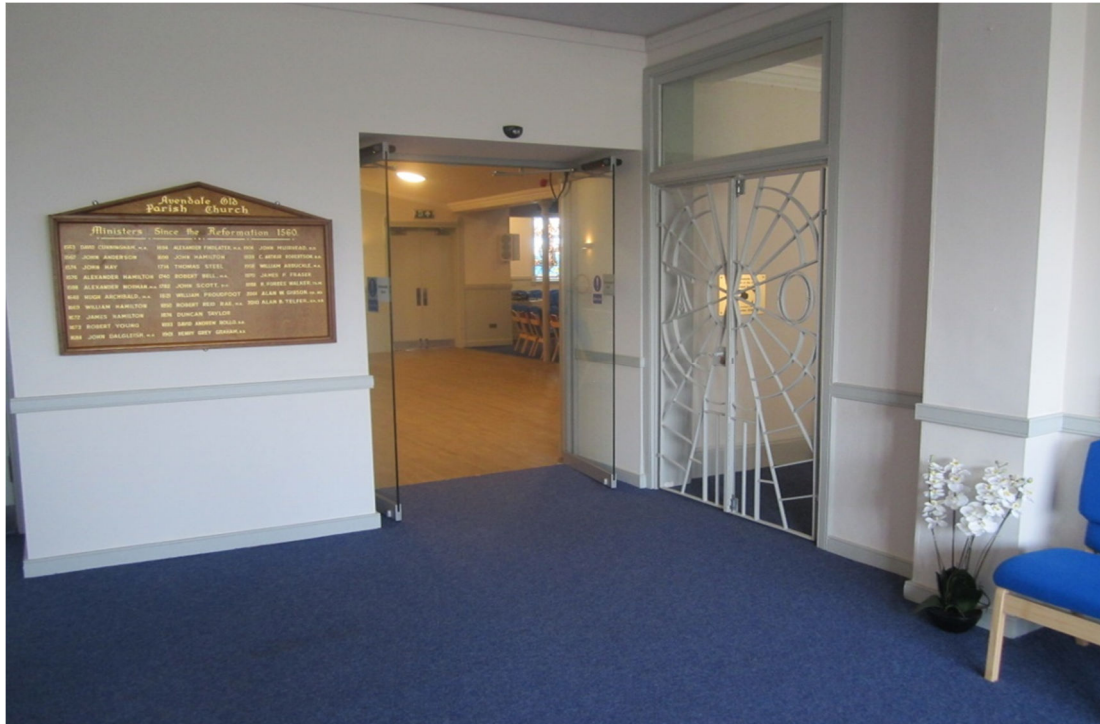
45 New electrically operated door from vestibule into sanctuary

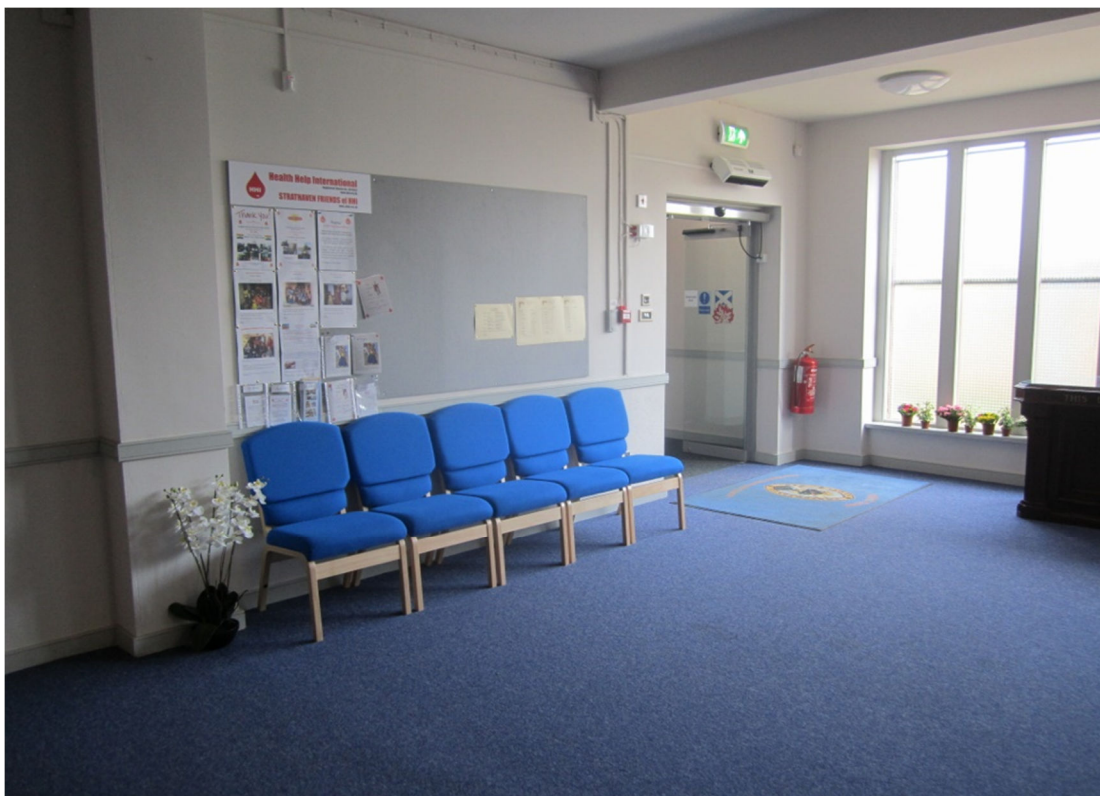
46 New electrically operated main entrance door

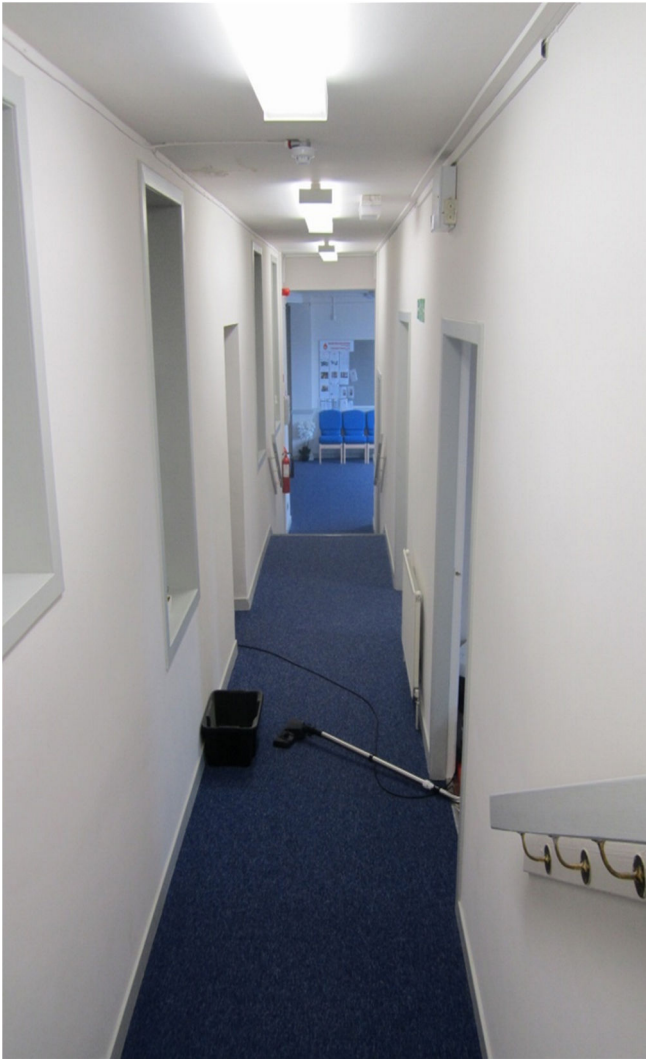
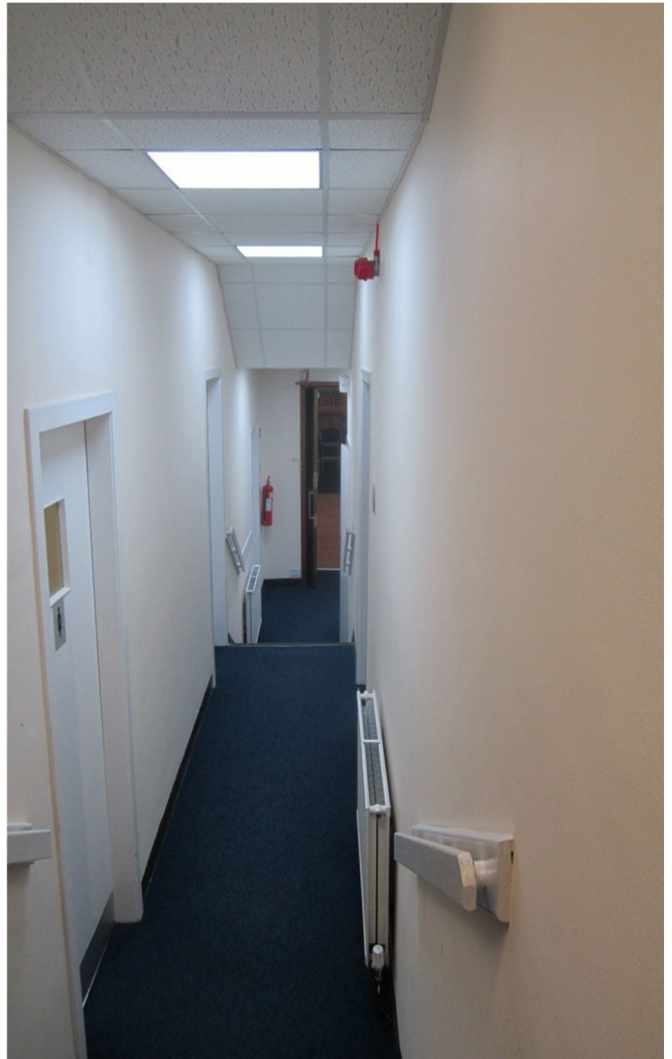
47 & 48 Corridors recarpeted and redecorated

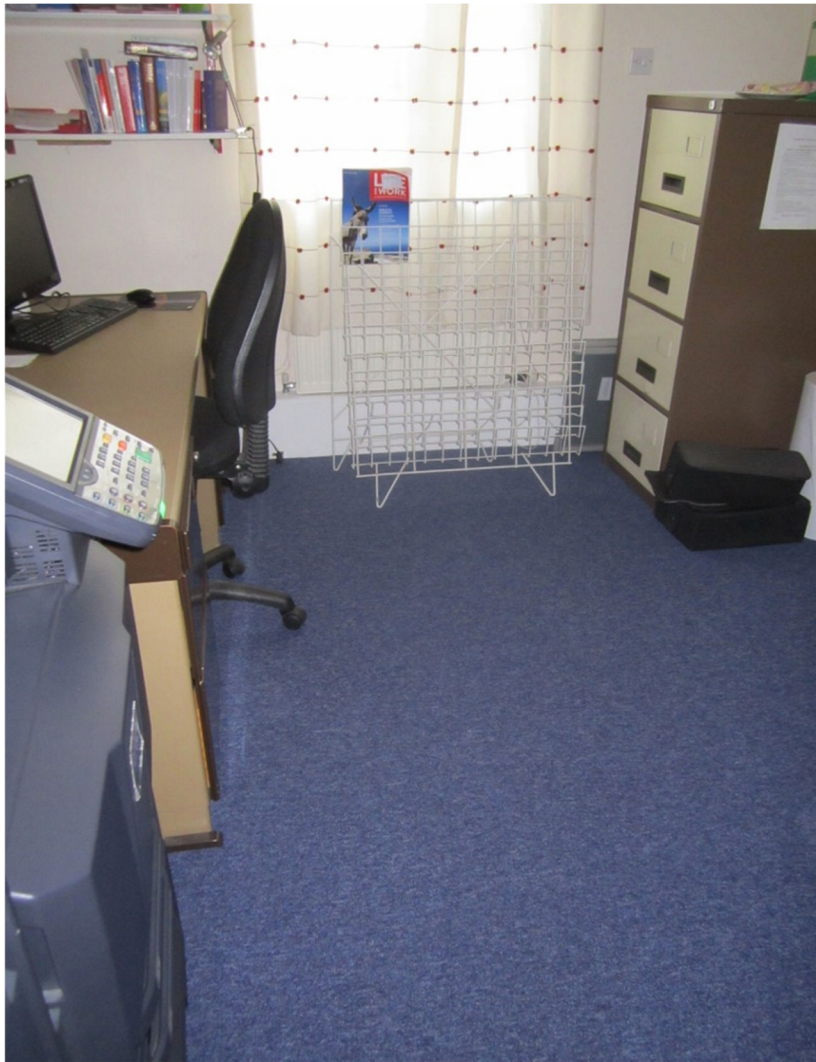
49 Office recarpeted

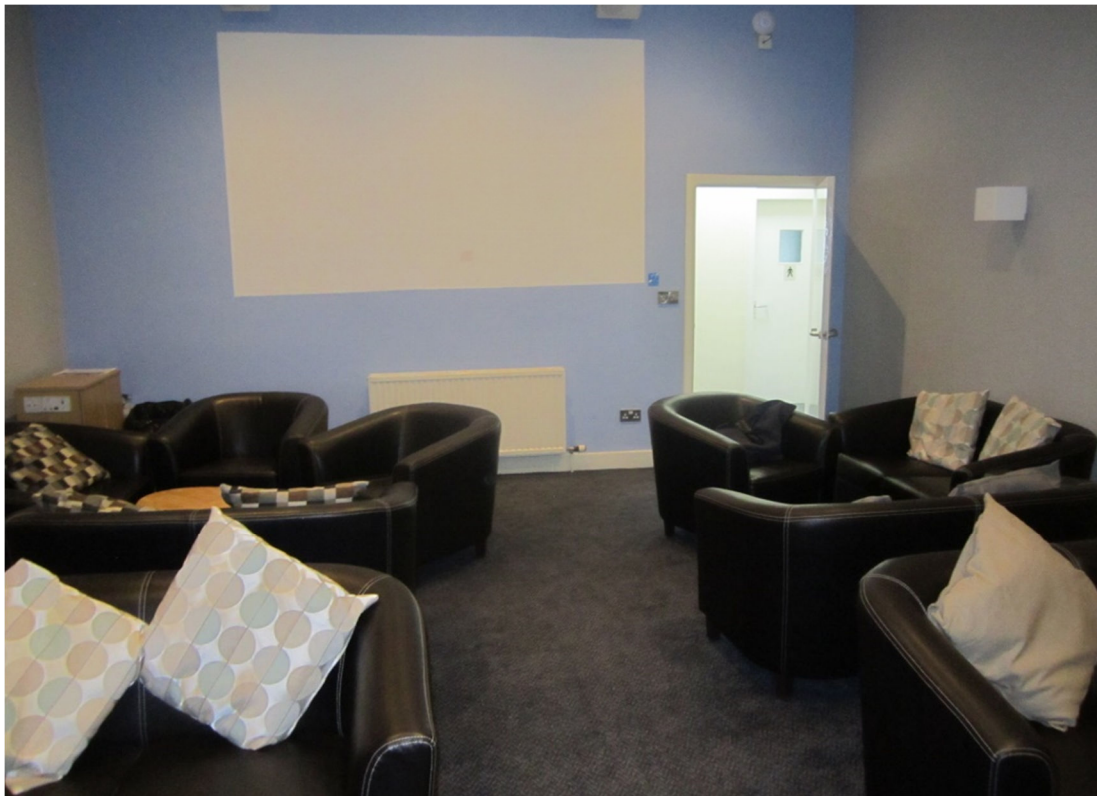
50 & 51 Loudoun Room refurbished since last report

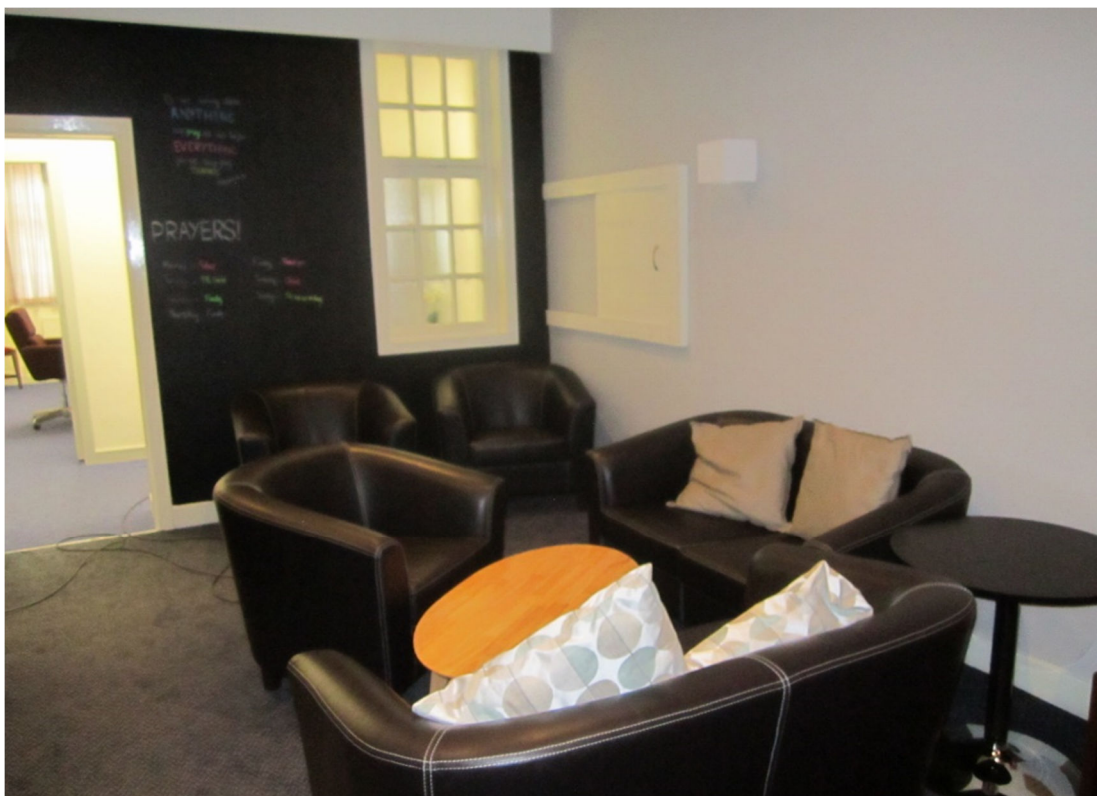
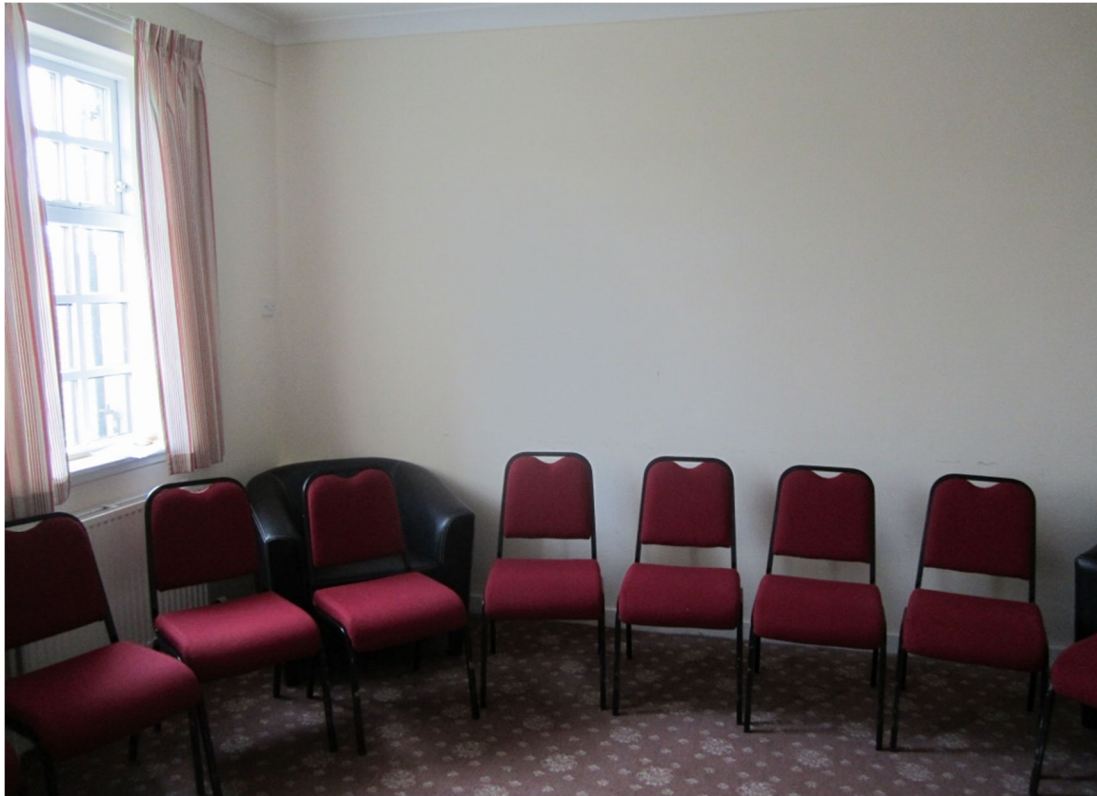
52 & 53 Small halls and rooms repaired and redecorated since last report

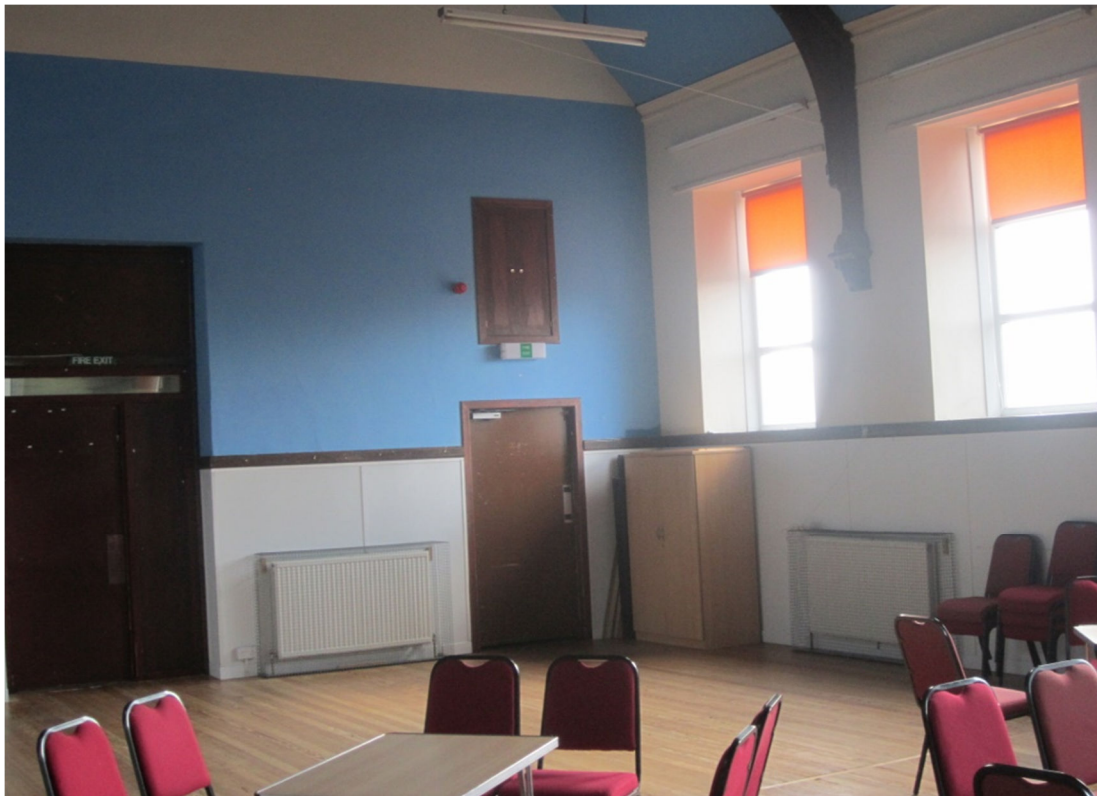
Emergency exit ironmongery has been replaced and exit signage rationalised.

54 Large hall fire signage rationalised since last

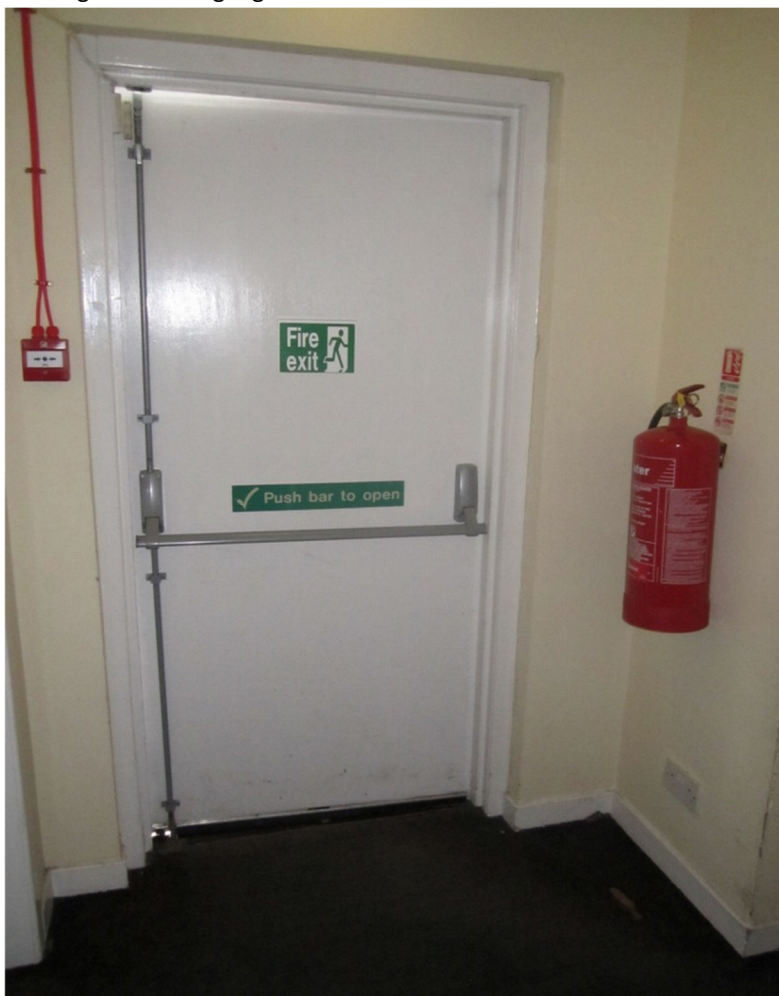
55 New fire escape ironmongery installed since last report

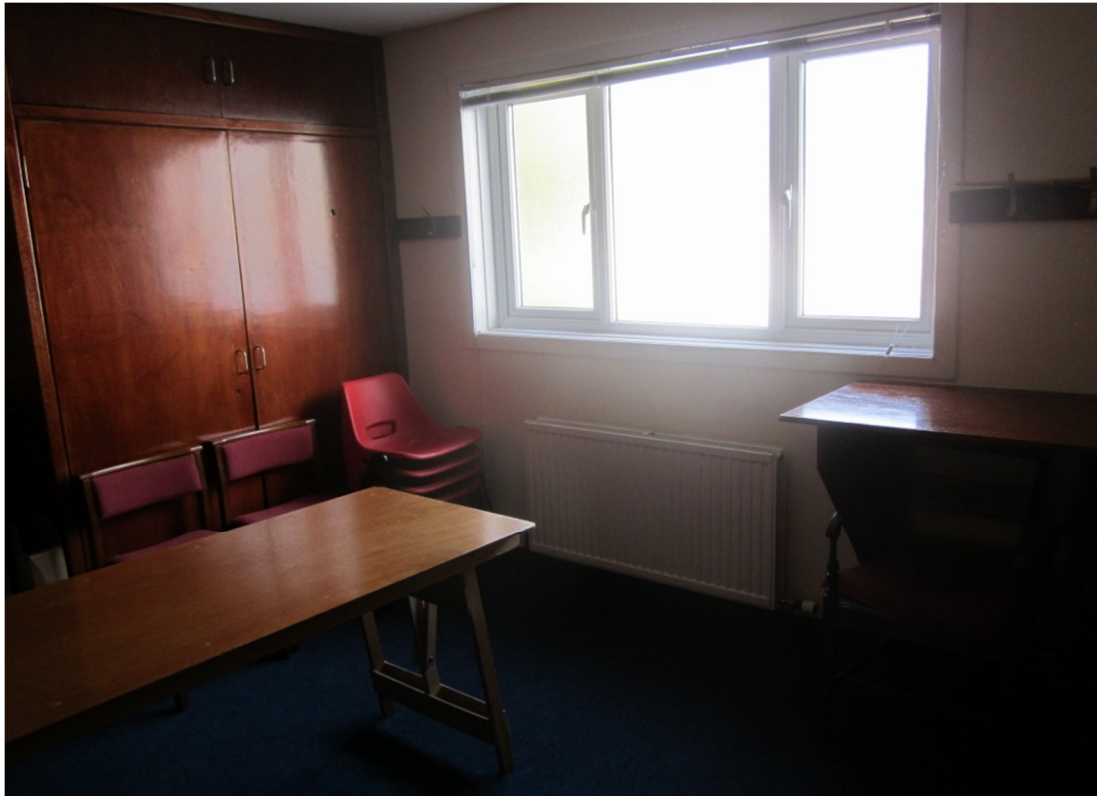
56 & 57 Auchingilloch Room redecorated since last report

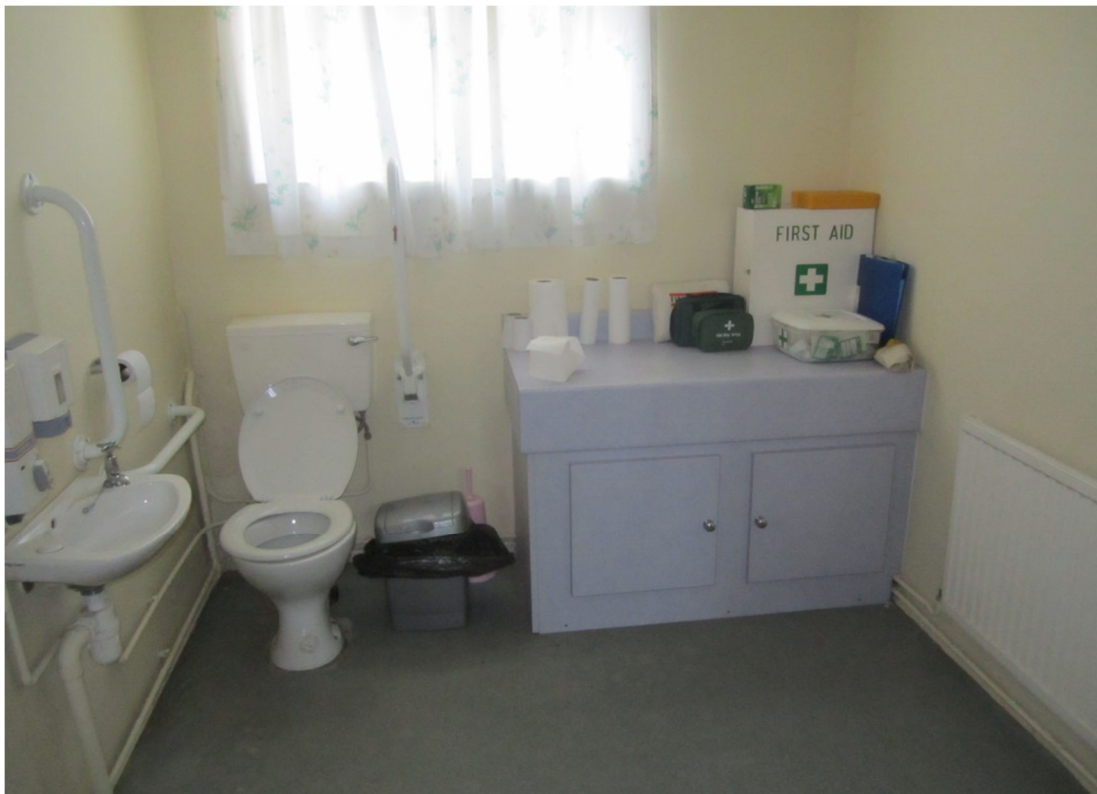
59 Accessible toilet - new unit fitted and room cleared since last report

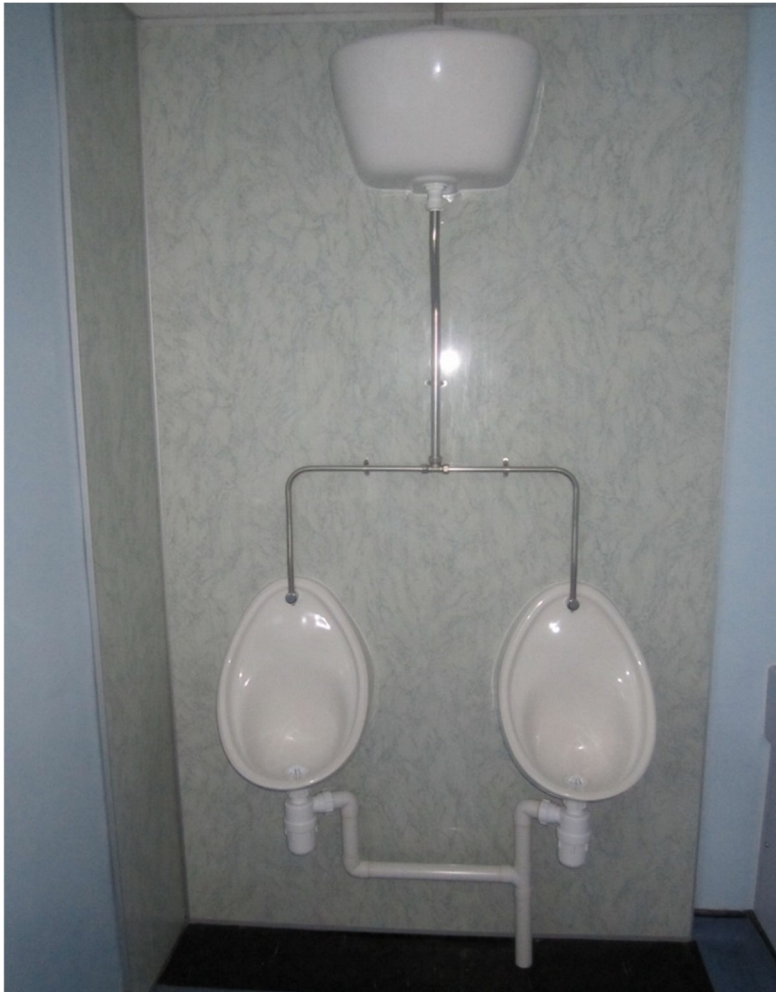
The urinal within the male toilet has been replaced and the wall and finishes made good, The accessible toilet has been cleared out. One wc within the female toilet is not working and this should be repaired.

60 Wall repaired in gents toilet and new urinals installed since last report
